Study Area 5: Downtown Pescadero
Pescadero, CA

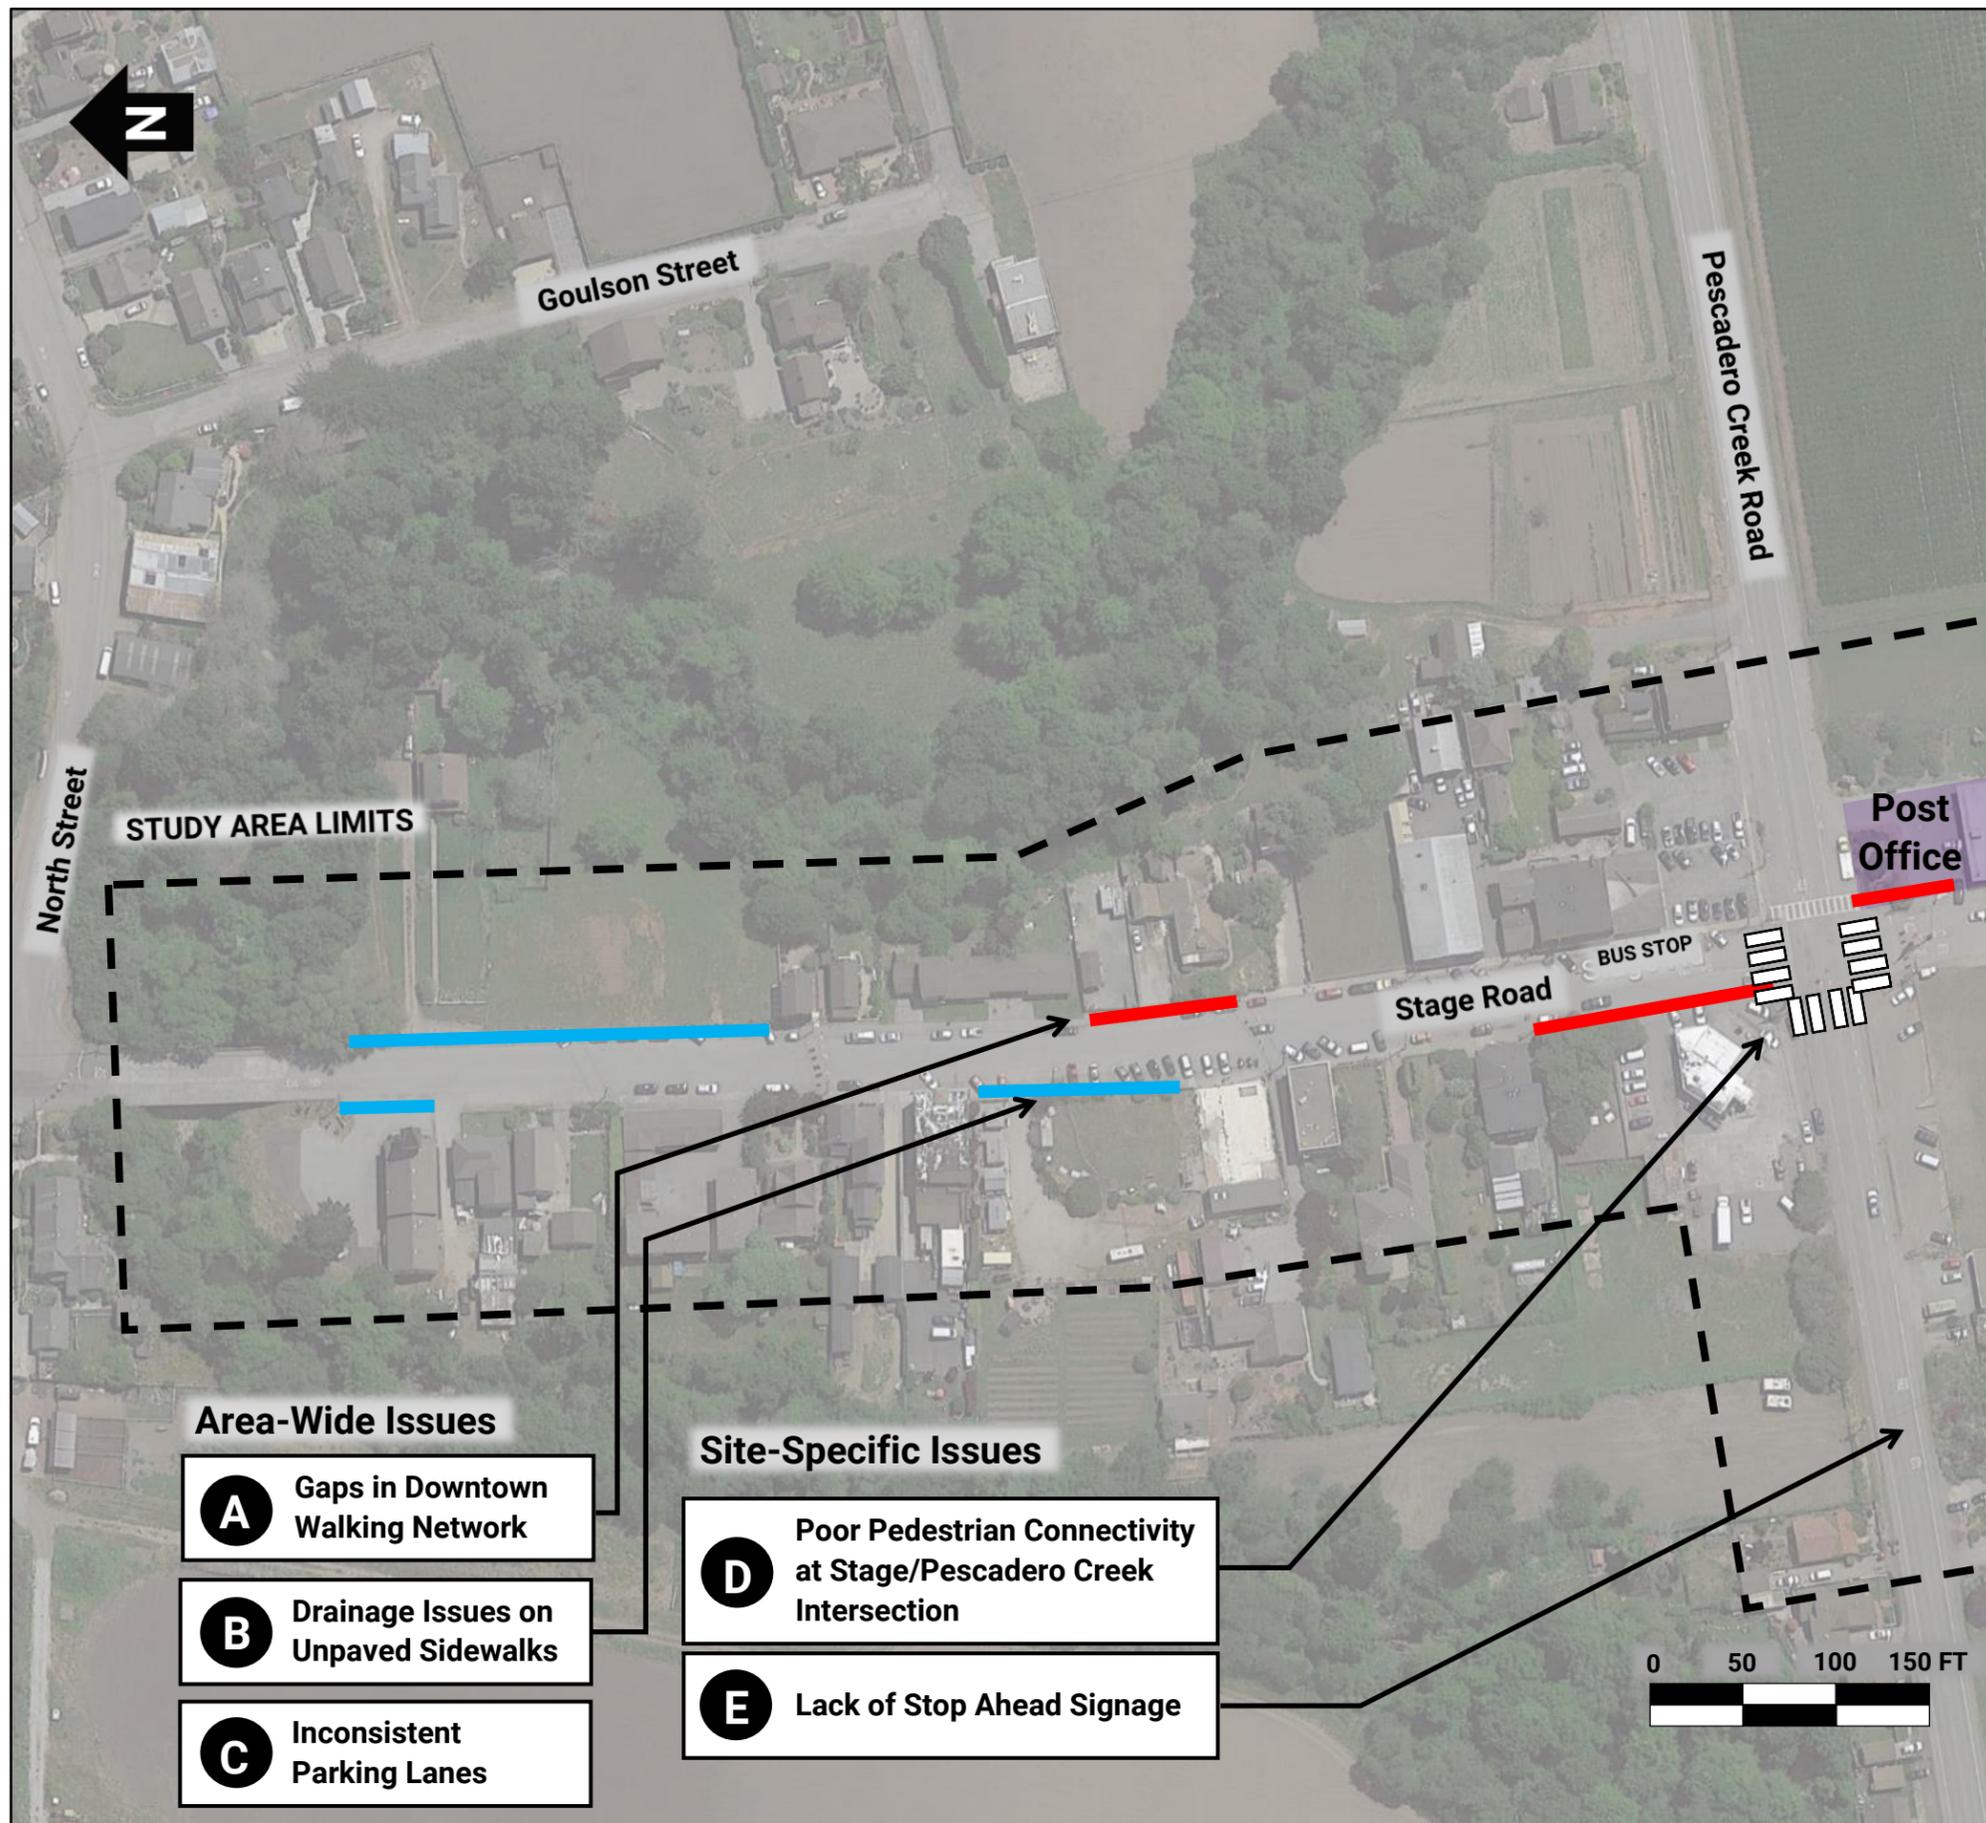
Issue	Recommendation
A —	Gaps in downtown walking network limit pedestrian connectivity in downtown Pescadero.	<p>Short-Term</p> <ul style="list-style-type: none"> Install vertical separation (e.g., wooden curb stops) to delineate unpaved shoulder parking lane from existing unpaved walkways Extend sidepath from Stage/Pescadero Creek intersection to Post Office <p>Long-Term</p> <ul style="list-style-type: none"> Install concrete sidewalks in front of Topia Antiques and gas station (areas without existing sidewalk infrastructure that abut existing concrete sidewalks)
B —	Drainage issues on unpaved sidewalks after rain events.	<p>Short-Term</p> <ul style="list-style-type: none"> Conduct regular sidewalk maintenance (i.e., fill depressions with new soil) <p>Long-Term</p> <ul style="list-style-type: none"> Install crushed gravel to reinforce and level unpaved walkways
C	Inconsistent parking lanes result in disorganized vehicle parking and vehicles encroaching in pedestrian space.	<p>Short-Term:</p> <ul style="list-style-type: none"> Reconfigure parking on each side of Stage Road to be consistent (i.e., all parallel or all diagonal) by striping parking spaces

D	Poor pedestrian connectivity at the Stage/Pescadero Creek intersection creates a safety and access issue for pedestrians going to the Post Office and other destinations to the south.	<p>Short-Term</p> <ul style="list-style-type: none"> Install high-visibility crosswalks on all four legs of the intersection <p>Long-Term</p> <ul style="list-style-type: none"> Install lighting at intersection to illuminate crosswalks
E	Lack of Stop Ahead Signage on Pescadero Creek Road on eastbound approach to Stage Road.	<p>Short-Term</p> <ul style="list-style-type: none"> Install Stop Ahead signage to augment existing Stop Ahead pavement markings
