SMC Unincorporated County Active Transportation Plan Draft Pedestrian Improvements

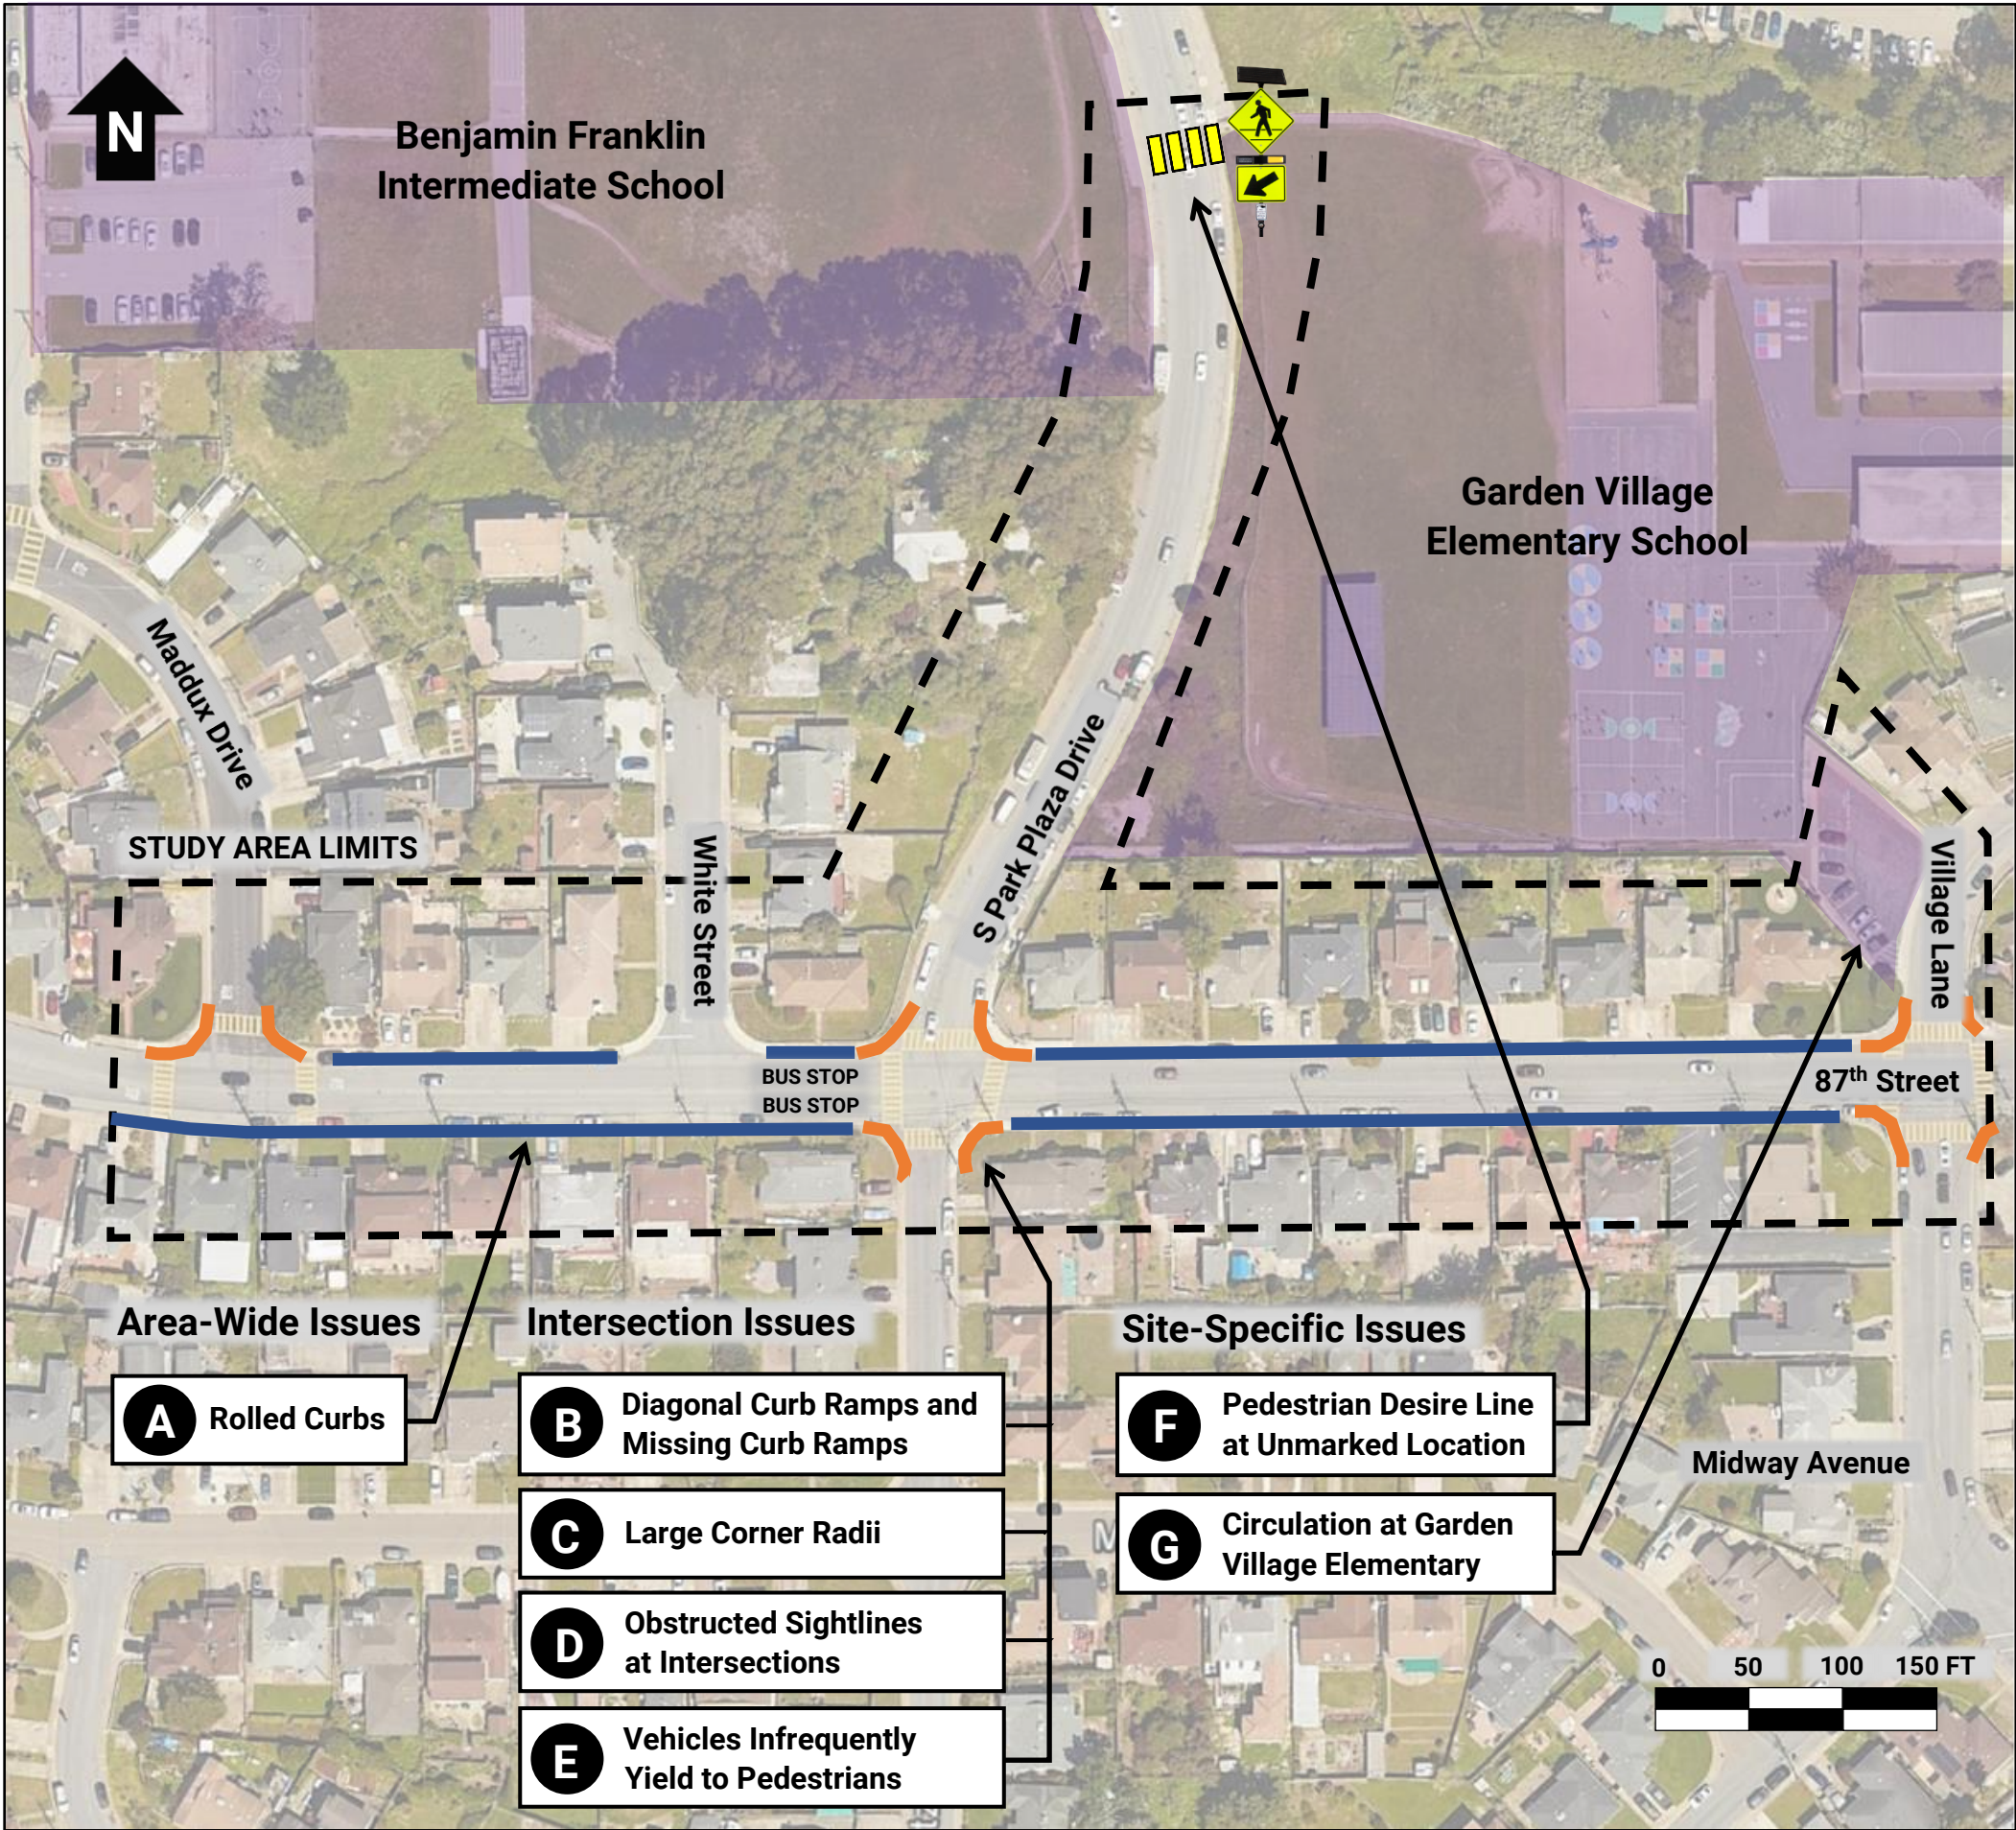
Study Area 1: Benjamin Franklin & Garden Village Schools
Broadmoor, CA

Issue	Recommendation
A	Rolled curbs encourage drivers to park partially on the sidewalk, resulting in pedestrian safety and access issues.	Short-Term <ul style="list-style-type: none">Stripe edge lines in roadway to delineate parking lanes from travel lanes or install rubber wheel stops flush with rolled curb to prevent sidewalk parkingConduct neighborhood educational campaign (e.g., windshield flyers) on good parking habits Long-Term <ul style="list-style-type: none">Retrofit rolled curbs to vertical curbs
B	Diagonal curb ramps and missing curb ramps are a safety and ADA access issue for pedestrians.	Long-Term <ul style="list-style-type: none">Install ADA-compliant bi-directional curb ramps that align with crosswalks at intersections on 87th Street with marked crossings
C	Large corner radii at intersections enable drivers to make high-speed right turns, which decreases the likelihood that they will yield to crossing pedestrians and increases the severity of collisions with pedestrians, should they occur.	Short-Term <ul style="list-style-type: none">Install quick-build curb extensions with smaller radii constructed from temporary materials like paint and flexible delineators Long-Term <ul style="list-style-type: none">Install concrete curb extensions with smaller radii (must account for existing drainage infrastructure)

D	Obstructed sightlines at intersections reduce the visibility of pedestrians and other vehicles to drivers.	Short-Term <ul style="list-style-type: none">Establish “no parking” zones within 20 feet of intersections Long-Term <ul style="list-style-type: none">Install concrete curb extensions
E	Turning vehicles infrequently yield to pedestrians , necessitating the use of crossing guards during school hours.	Short-Term <ul style="list-style-type: none">Install Leading Pedestrian Intervals (LPIs) at signalized intersections, which provide pedestrians with a walk signal 3 to 7 seconds before vehicles traveling in the same direction receive a green indication, so pedestrians establish the right-of-way in the crosswalk
F	Pedestrian desire line at unmarked location results in unsafe midblock jaywalking.	Long-Term <ul style="list-style-type: none">Install marked crossing, RRFBs, curb extensions, and curb ramps

G	Circulation at Garden Village Elementary is inefficient and results in a narrow pedestrian entrance to the school.	Short-Term <ul style="list-style-type: none">Use temporary materials like cones to reconfigure the drop-off zone on Village Lane into a semi-circular circulation loop without parking spaces and a smaller footprint Long-Term <ul style="list-style-type: none">Use permanent installations like curbing and landscaping to reconfigure the drop-off zone into a circulation loop and widen the sidewalk to the school campus

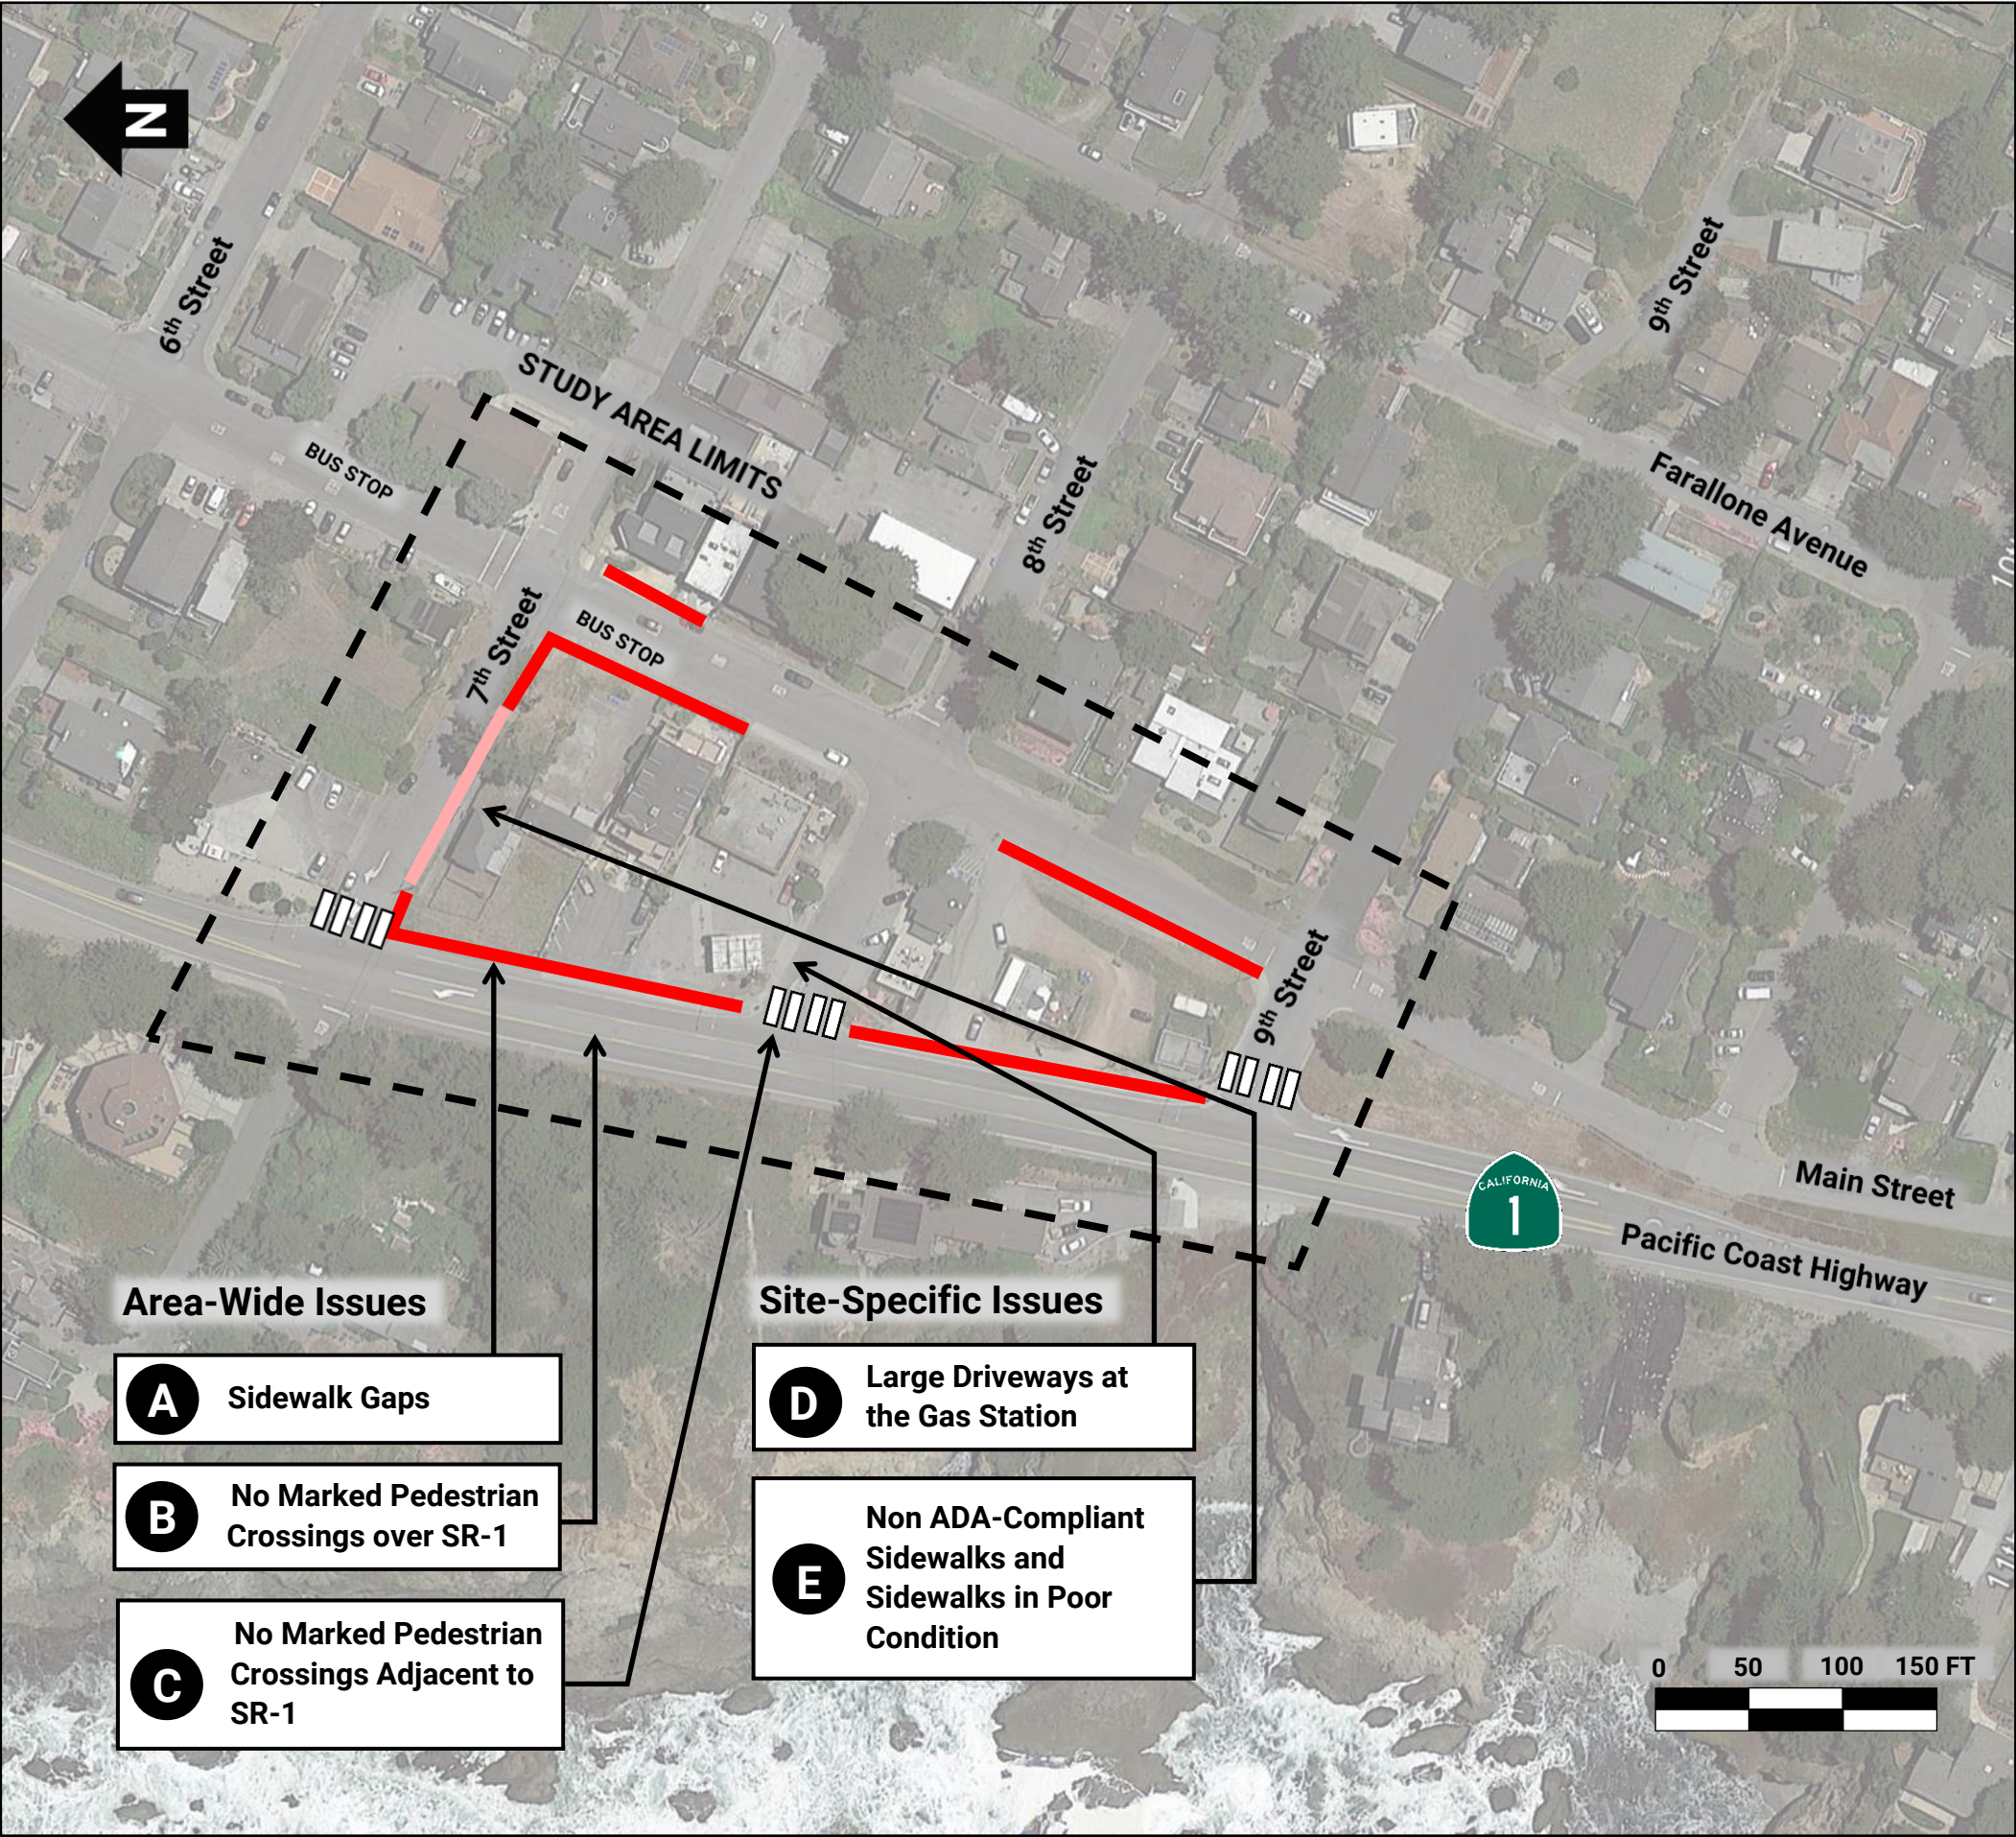
Study Area 2: Downtown Montara
Montara, CA

Issue	Recommendation
A

Sidewalk gaps result in a disconnected and inaccessible downtown walking network.	Short-Term <ul style="list-style-type: none">Install vertical separation (e.g., wooden curb stops) to delineate travel lane from paved shoulder in areas without existing sidewalk infrastructure Long-Term <ul style="list-style-type: none">Install concrete sidewalks in areas without existing sidewalk infrastructure that abut existing concrete sidewalks
B	No marked pedestrian crossings over SR-1 result in Montara being disconnected from the coastline and development on the west side of SR-1.	See the forthcoming Caltrans District 4 Pedestrian Plan for additional opportunities for pedestrian facilities along and across Caltrans right-of-way. See Highway 1 Safety and Mobility Study Phase 2 for additional long-term recommendations for pedestrian facilities along SR-1 and within Downtown Montara: planning.smcgov.org/sites/planning.smcgov.org/files/SMM_Ph_2_Study_Final_LR.pdf

C	No marked pedestrian crossings adjacent to SR-1 result in lower pedestrian visibility for high-speed vehicles turning off of SR-1.	Long-Term <ul style="list-style-type: none">Install marked crosswalks at 7th, 8th, and 9th StreetsInstall accessible landing pads at ends of marked crosswalks
D	Large driveways at the gas station create additional pedestrian/vehicle conflict zones.	Long-Term <ul style="list-style-type: none">Remove eastern gas station driveway on 8th Street and reduce widths of remaining driveways to reduce speeds of vehicles turning into gas station (requires coordination with property owner)
E

Non ADA-compliant sidewalks and sidewalks in poor condition make walking less enjoyable and are a barrier to pedestrian access.	Short-Term <ul style="list-style-type: none">Conduct regular sidewalk maintenance Long-Term <ul style="list-style-type: none">Repair damaged sidewalks and construct accessible landings at intersections

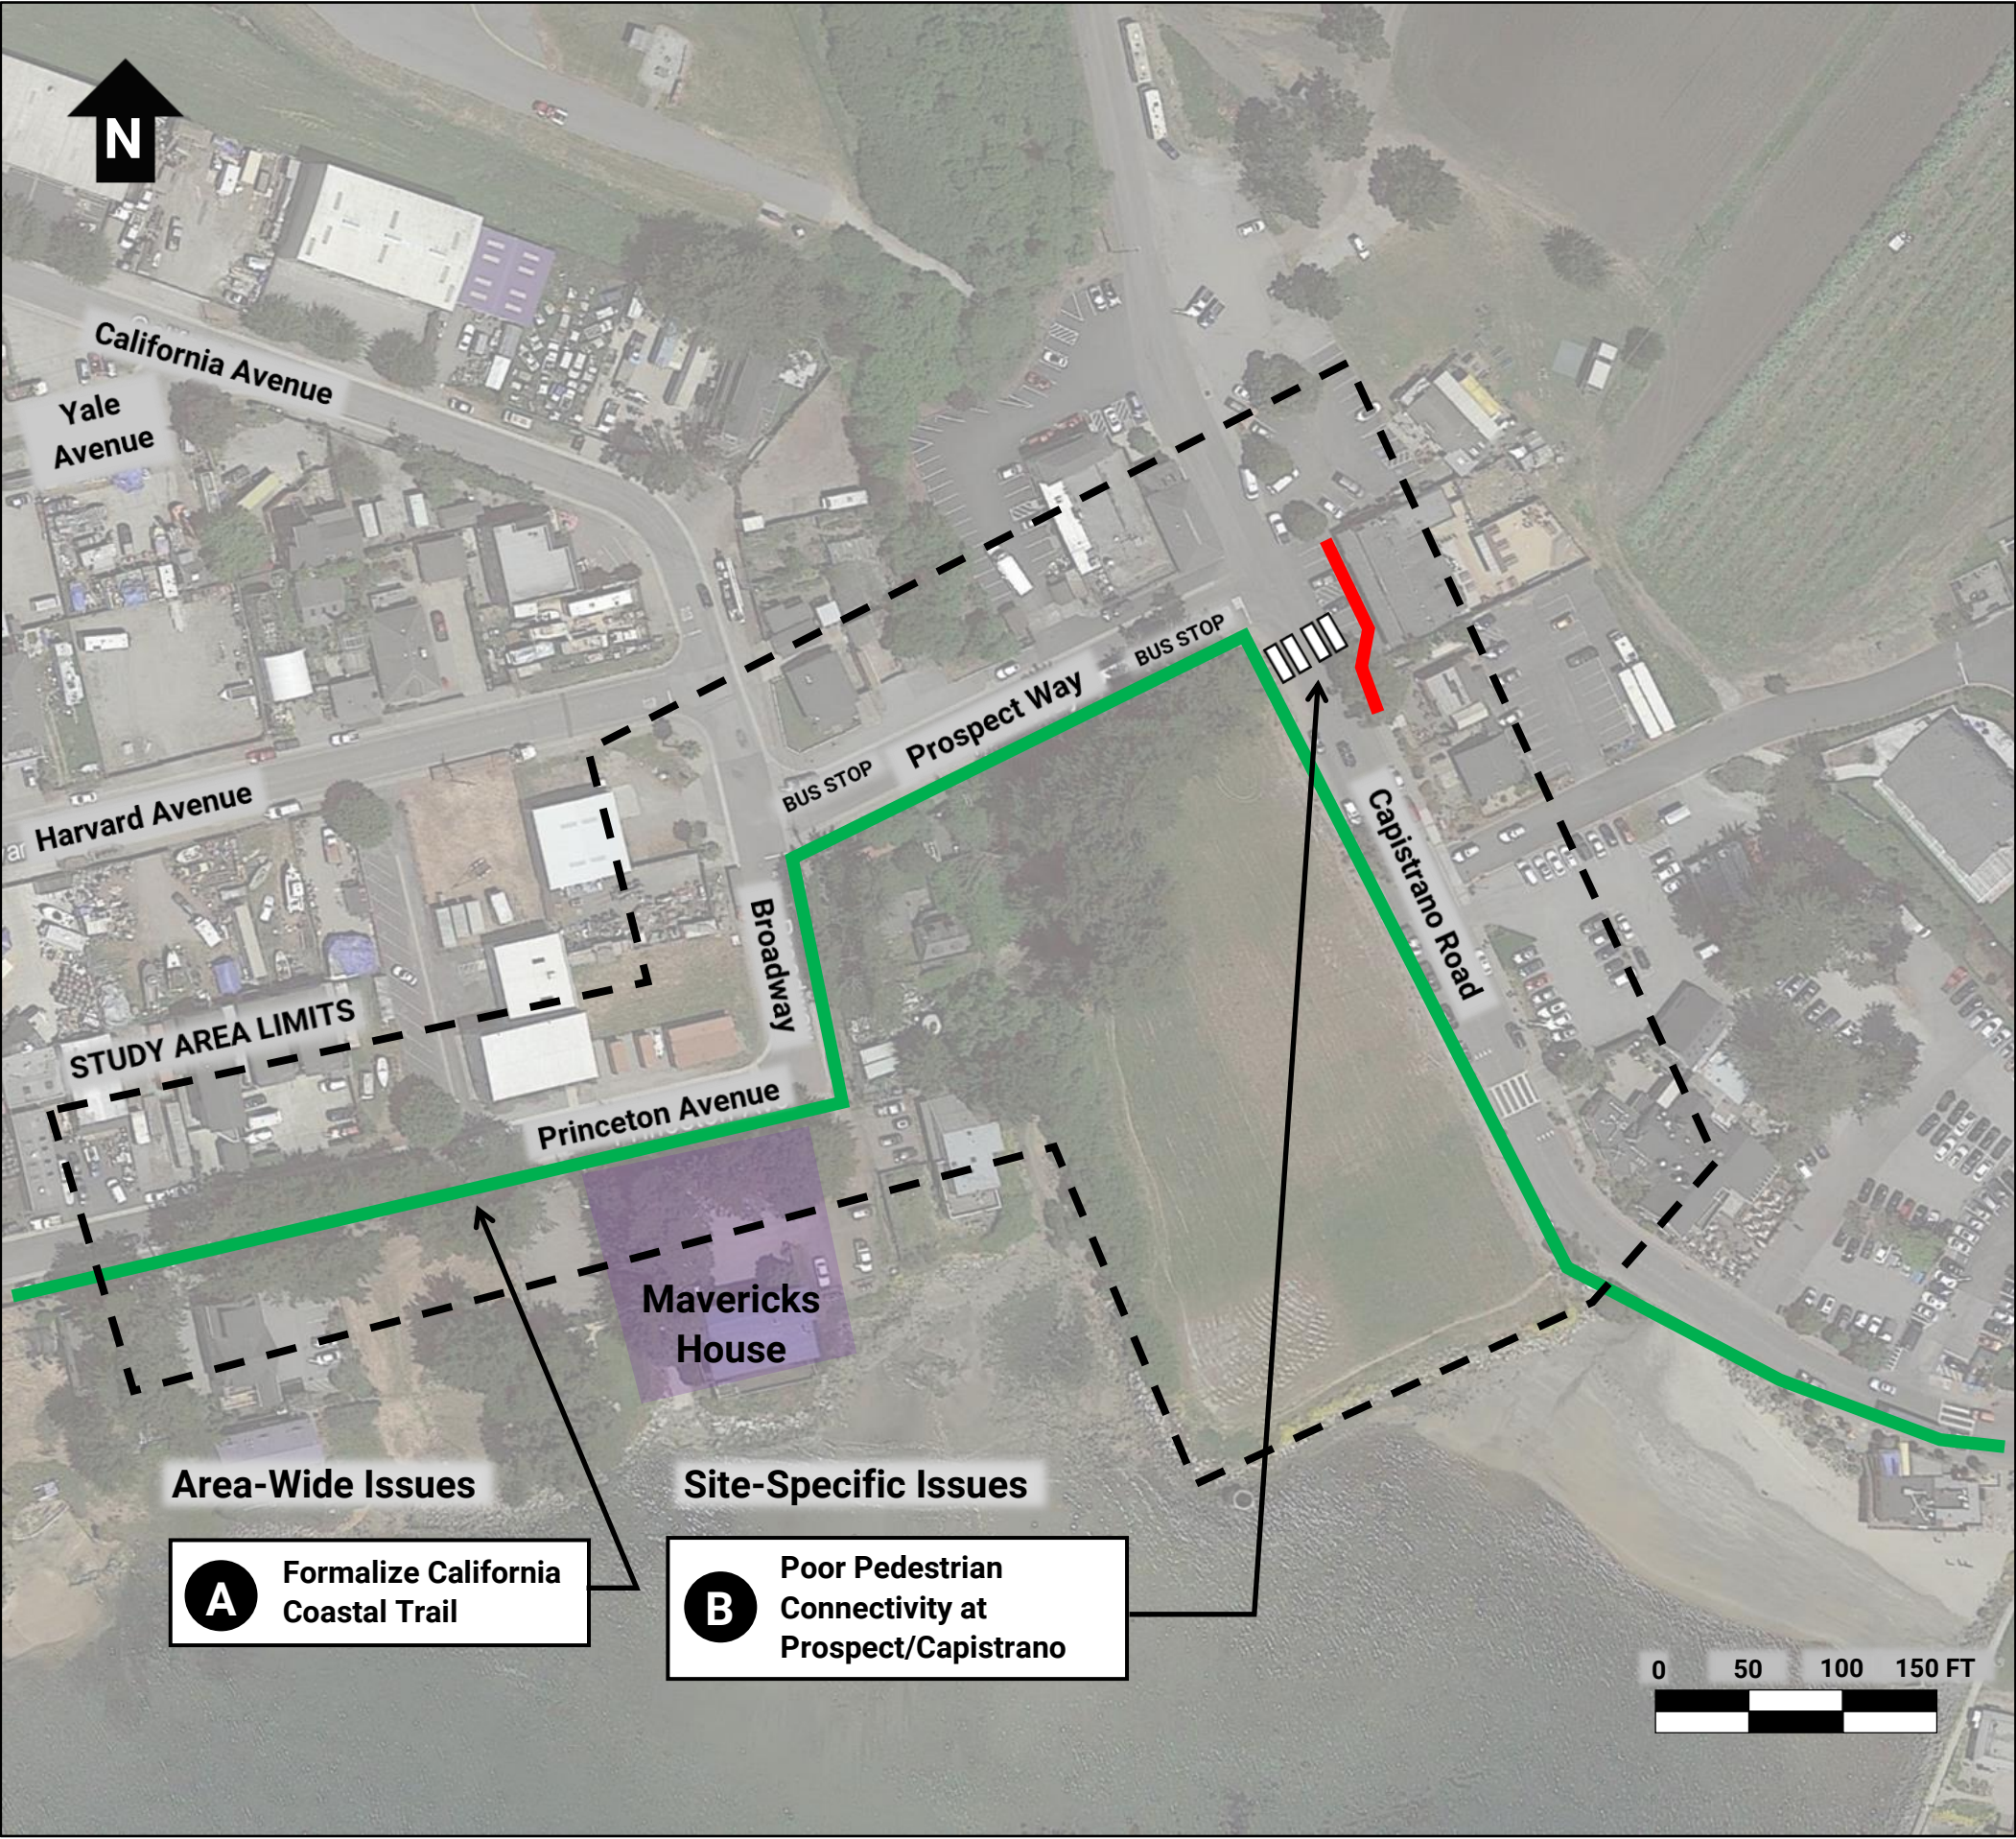
Study Area 3: Mavericks House Event Center
Princeton, CA

Issue	Recommendation
A	Formalize the California Coastal Trail by adding wayfinding and lighting to make it more comfortable and intuitive to navigate.	Short-Term <ul style="list-style-type: none">Install wayfinding signage along trail Long-Term <ul style="list-style-type: none">Add pedestrian-scale lighting along the California Coastal Trail in Princeton and in vicinity of Event Center
B	Poor pedestrian connectivity at the Prospect/Capistrano intersection creates a safety and access issue for pedestrians going to local businesses.	Short-Term <ul style="list-style-type: none">Install stop signs and stop bars on Capistrano Road at Prospect Way to create three-way stop-controlled intersectionFormalize a walkway behind parking spaces in front of the Old Princeton Landing Pub & Grill Long-Term <ul style="list-style-type: none">Install a marked crosswalk and curb ramps on the eastern leg of the Prospect/Capistrano intersection to provide connectivity across Capistrano (requires coordination with property owner)

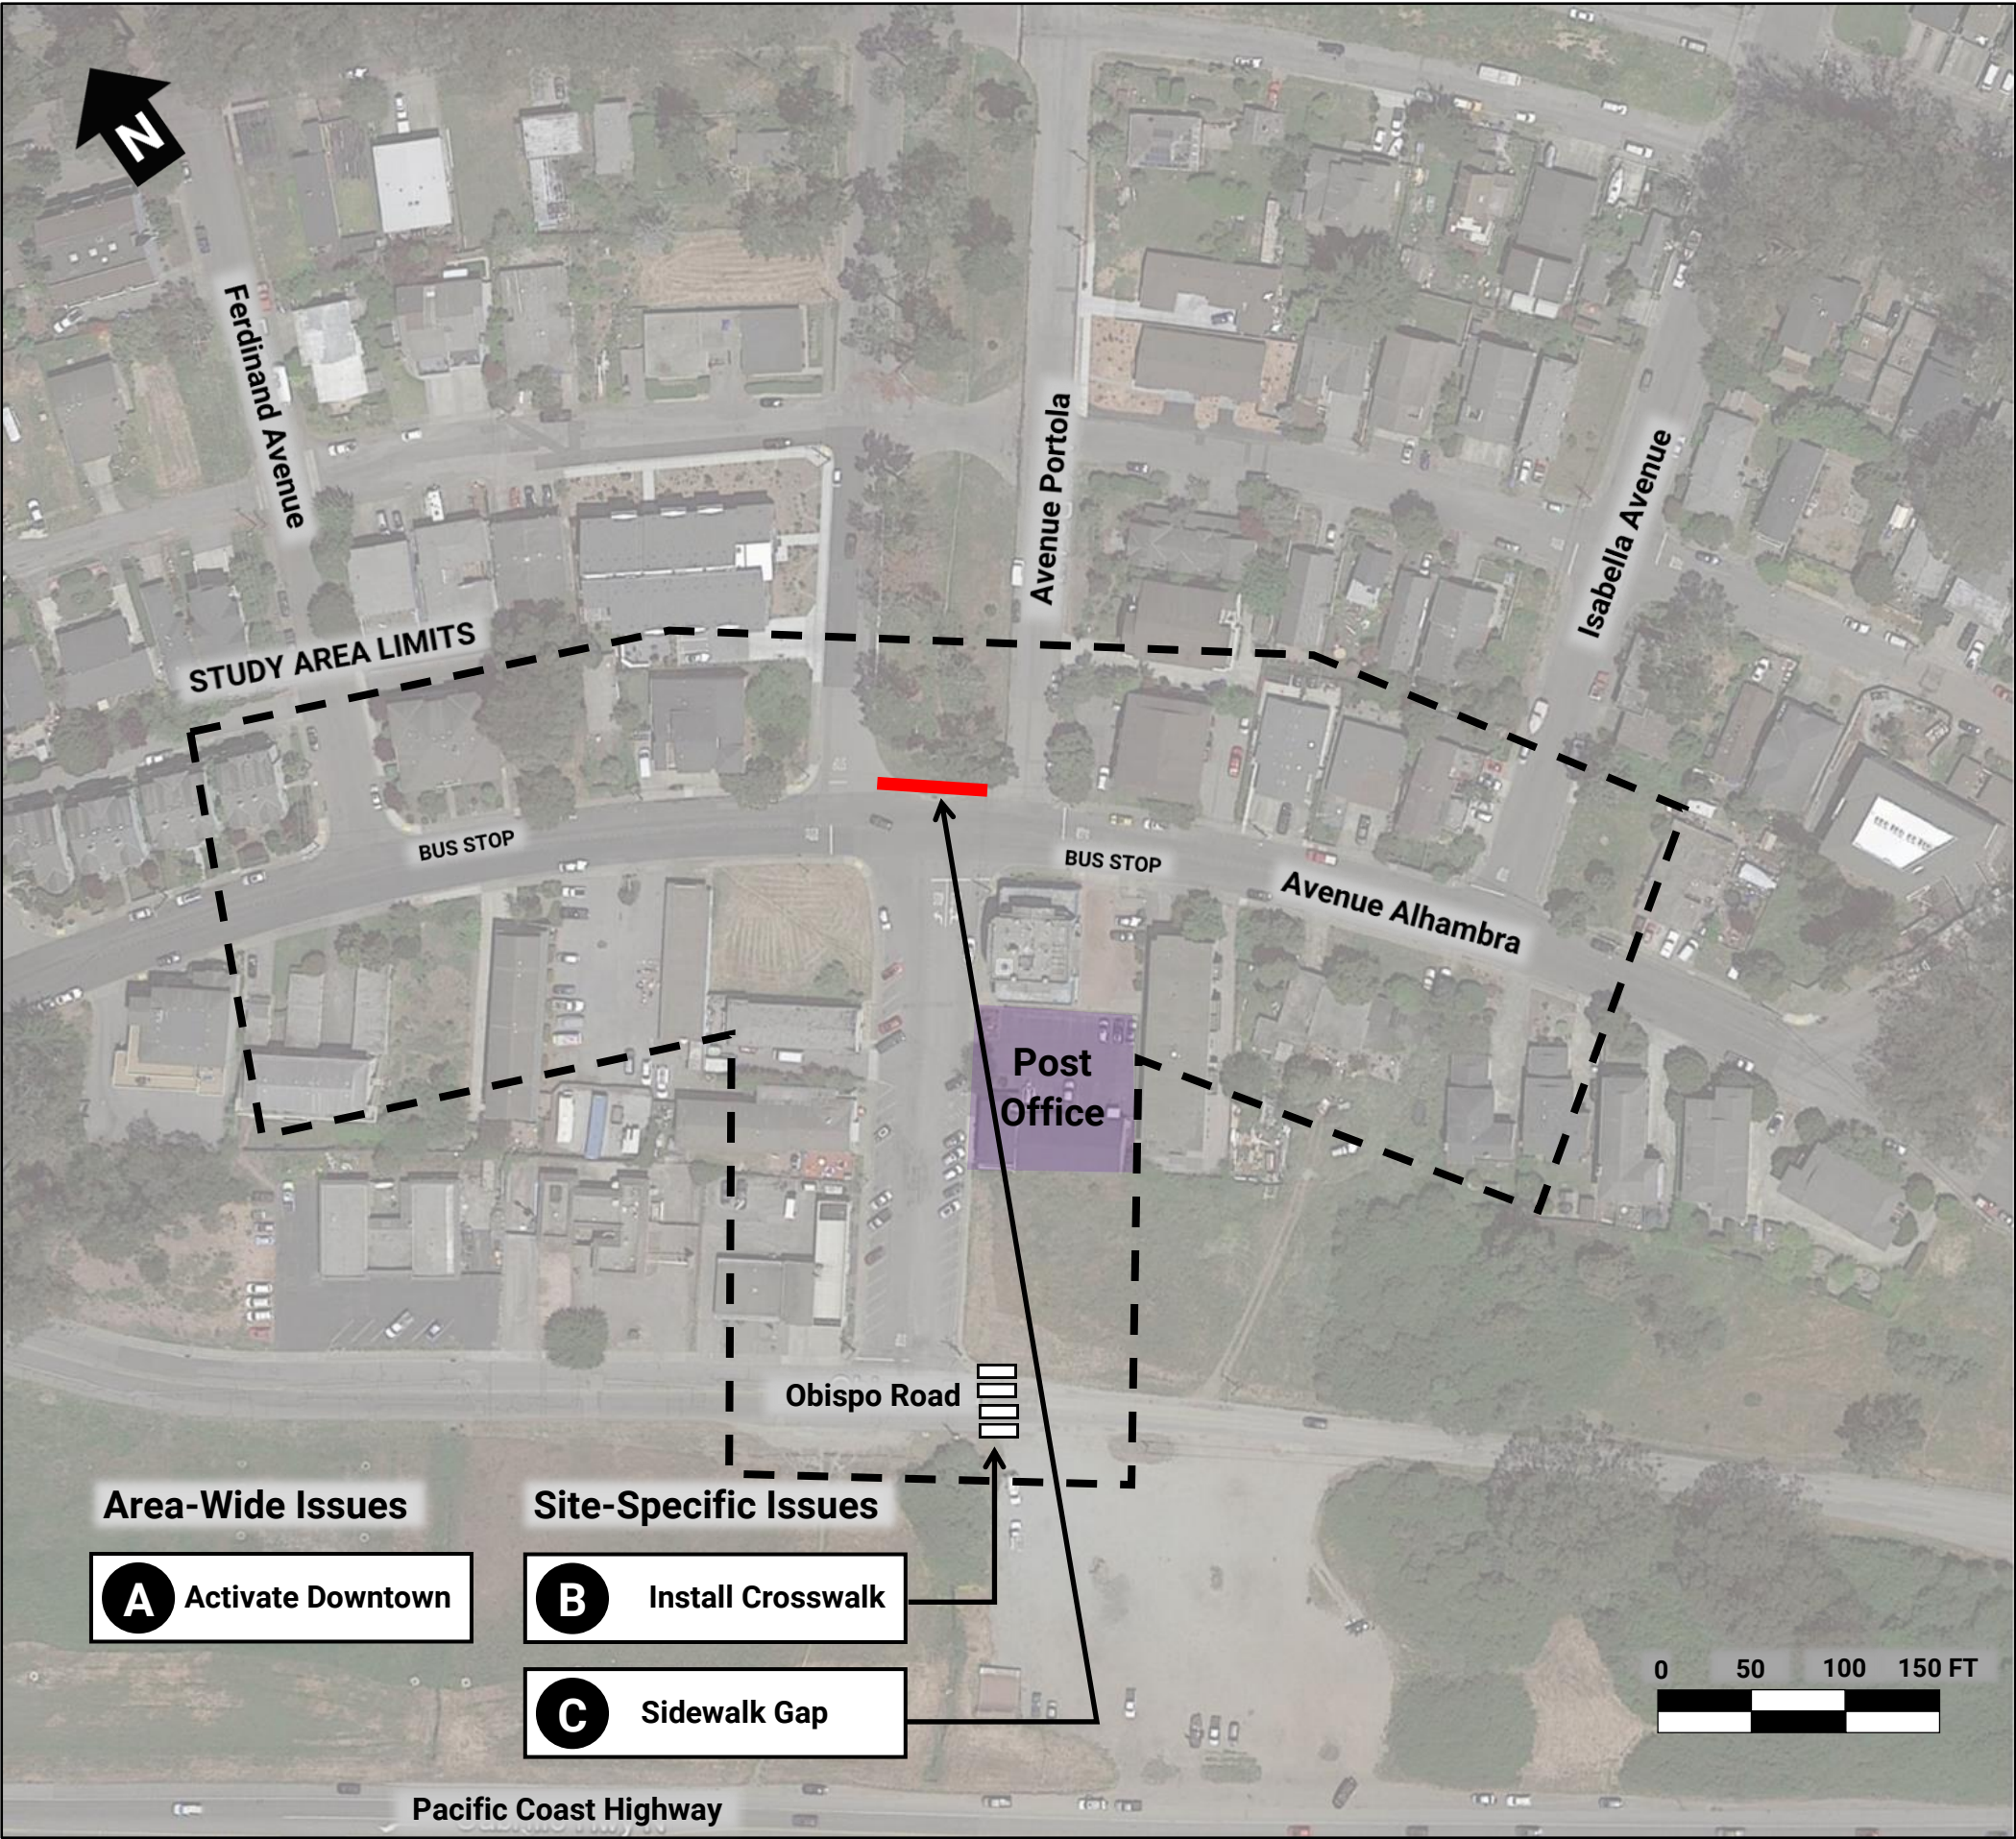
Study Area 4: Downtown El Granada
El Granada, CA

Issue	Recommendation
A	Activate downtown , which is currently automobile-focused.	Short-Term <ul style="list-style-type: none">Seal coat existing parking lanes on Avenue Portola from Avenue Alhambra to Obispo Road with colored patterns to visually narrow roadway and delineate parking lanes from travel lanesConvert several parking spaces to planters or parklets to activate El Granada’s downtown Long-Term <ul style="list-style-type: none">Reconstruct Avenue Portola from Avenue Alhambra to Obispo Road with wider sidewalks, street trees, and a narrower curb-to-curb street width
B	Install crosswalk on Obispo Road to connect southern parking lot to downtown businesses.	Short-Term <ul style="list-style-type: none">Install crosswalk on southeastern leg of Obispo/Portola intersection
C	Sidewalk gap at Portola/Alhambra intersection.	Long-Term <ul style="list-style-type: none">Install concrete sidewalk and curb ramps

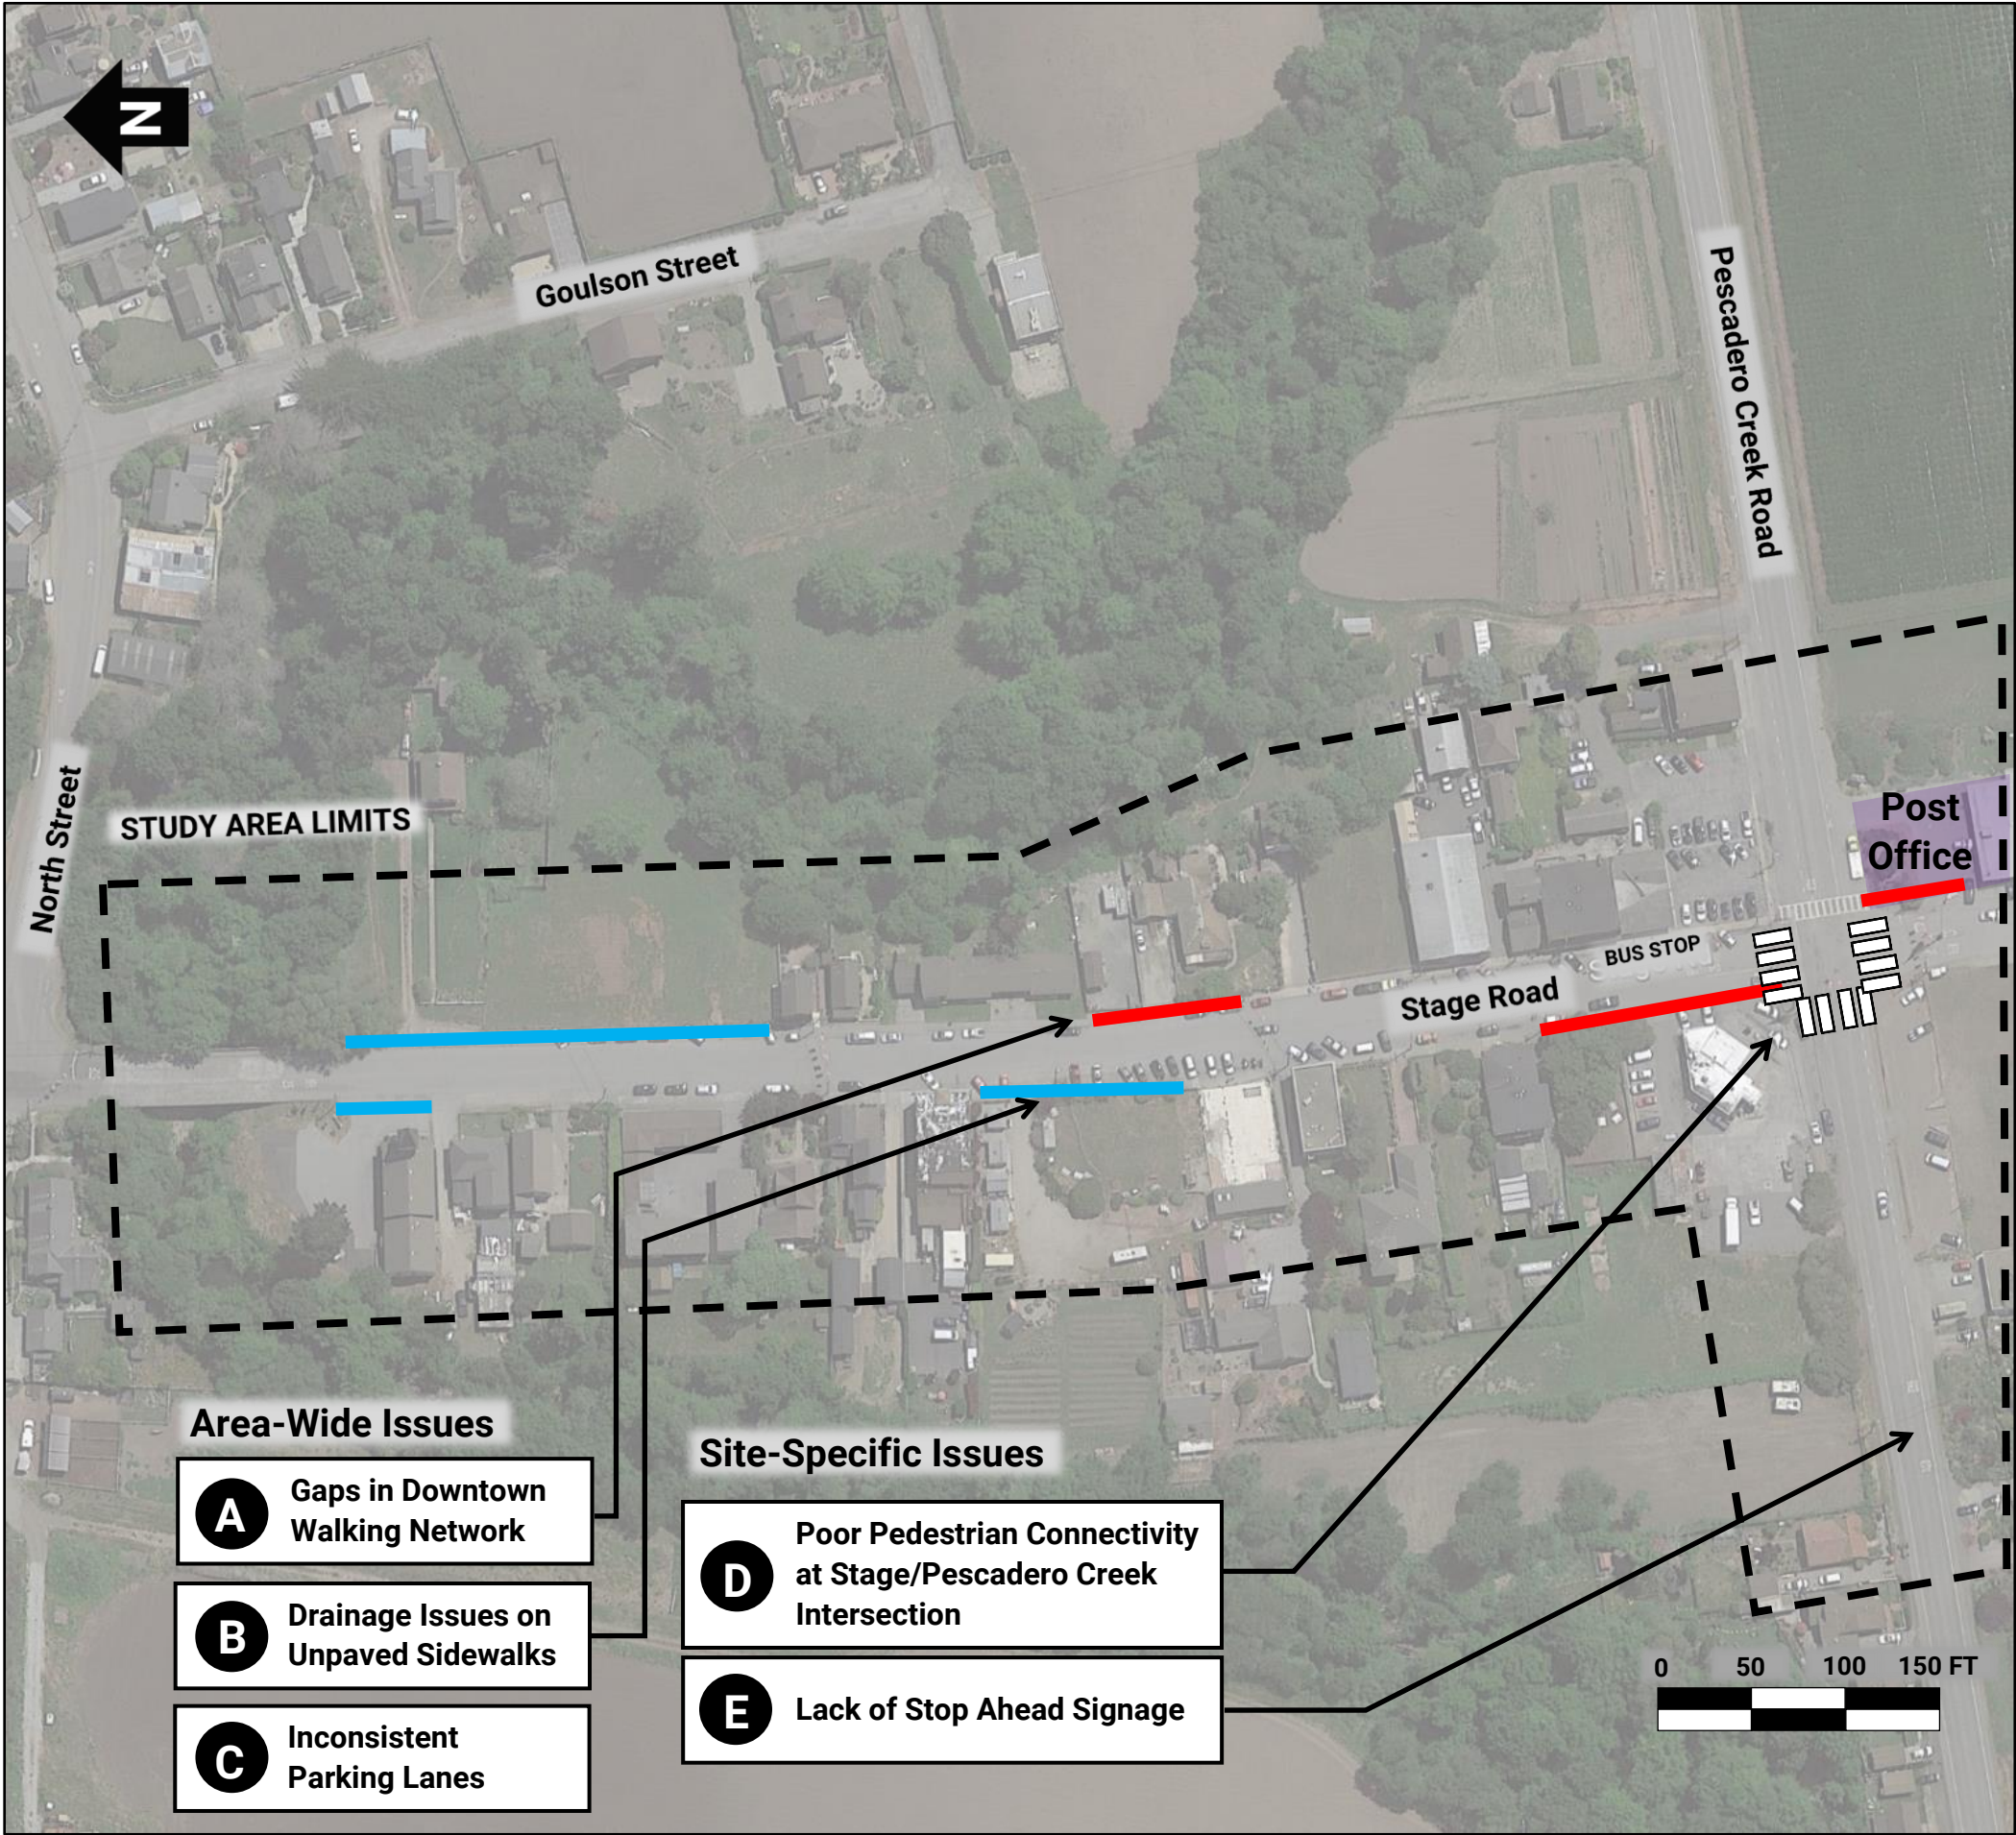
Study Area 5: Downtown Pescadero
Pescadero, CA

Issue	Recommendation
A	Gaps in downtown walking network limit pedestrian connectivity in downtown Pescadero.	Short-Term <ul style="list-style-type: none">Install vertical separation (e.g., wooden curb stops) to delineate unpaved shoulder parking lane from existing unpaved walkwaysExtend sidepath from Stage/Pescadero Creek intersection to Post Office Long-Term <ul style="list-style-type: none">Install concrete sidewalks in front of Topia Antiques and gas station (areas without existing sidewalk infrastructure that abut existing concrete sidewalks)
B	Drainage issues on unpaved sidewalks after rain events.	Short-Term <ul style="list-style-type: none">Conduct regular sidewalk maintenance (i.e., fill depressions with new soil) Long-Term <ul style="list-style-type: none">Install crushed gravel to reinforce and level unpaved walkways
C	Inconsistent parking lanes result in disorganized vehicle parking and vehicles encroaching in pedestrian space.	Short-Term: <ul style="list-style-type: none">Reconfigure parking on each side of Stage Road to be consistent (i.e., all parallel or all diagonal) by striping parking spaces

D	Poor pedestrian connectivity at the Stage/Pescadero Creek intersection creates a safety and access issue for pedestrians going to the Post Office and other destinations to the south.	Short-Term <ul style="list-style-type: none">Install high-visibility crosswalks on all four legs of the intersection Long-Term <ul style="list-style-type: none">Install lighting at intersection to illuminate crosswalks
E	Lack of Stop Ahead Signage on Pescadero Creek Road on eastbound approach to Stage Road.	Short-Term <ul style="list-style-type: none">Install Stop Ahead signage to augment existing Stop Ahead pavement markings
