SMC Unincorporated County Active Transportation Plan Draft Pedestrian Improvements

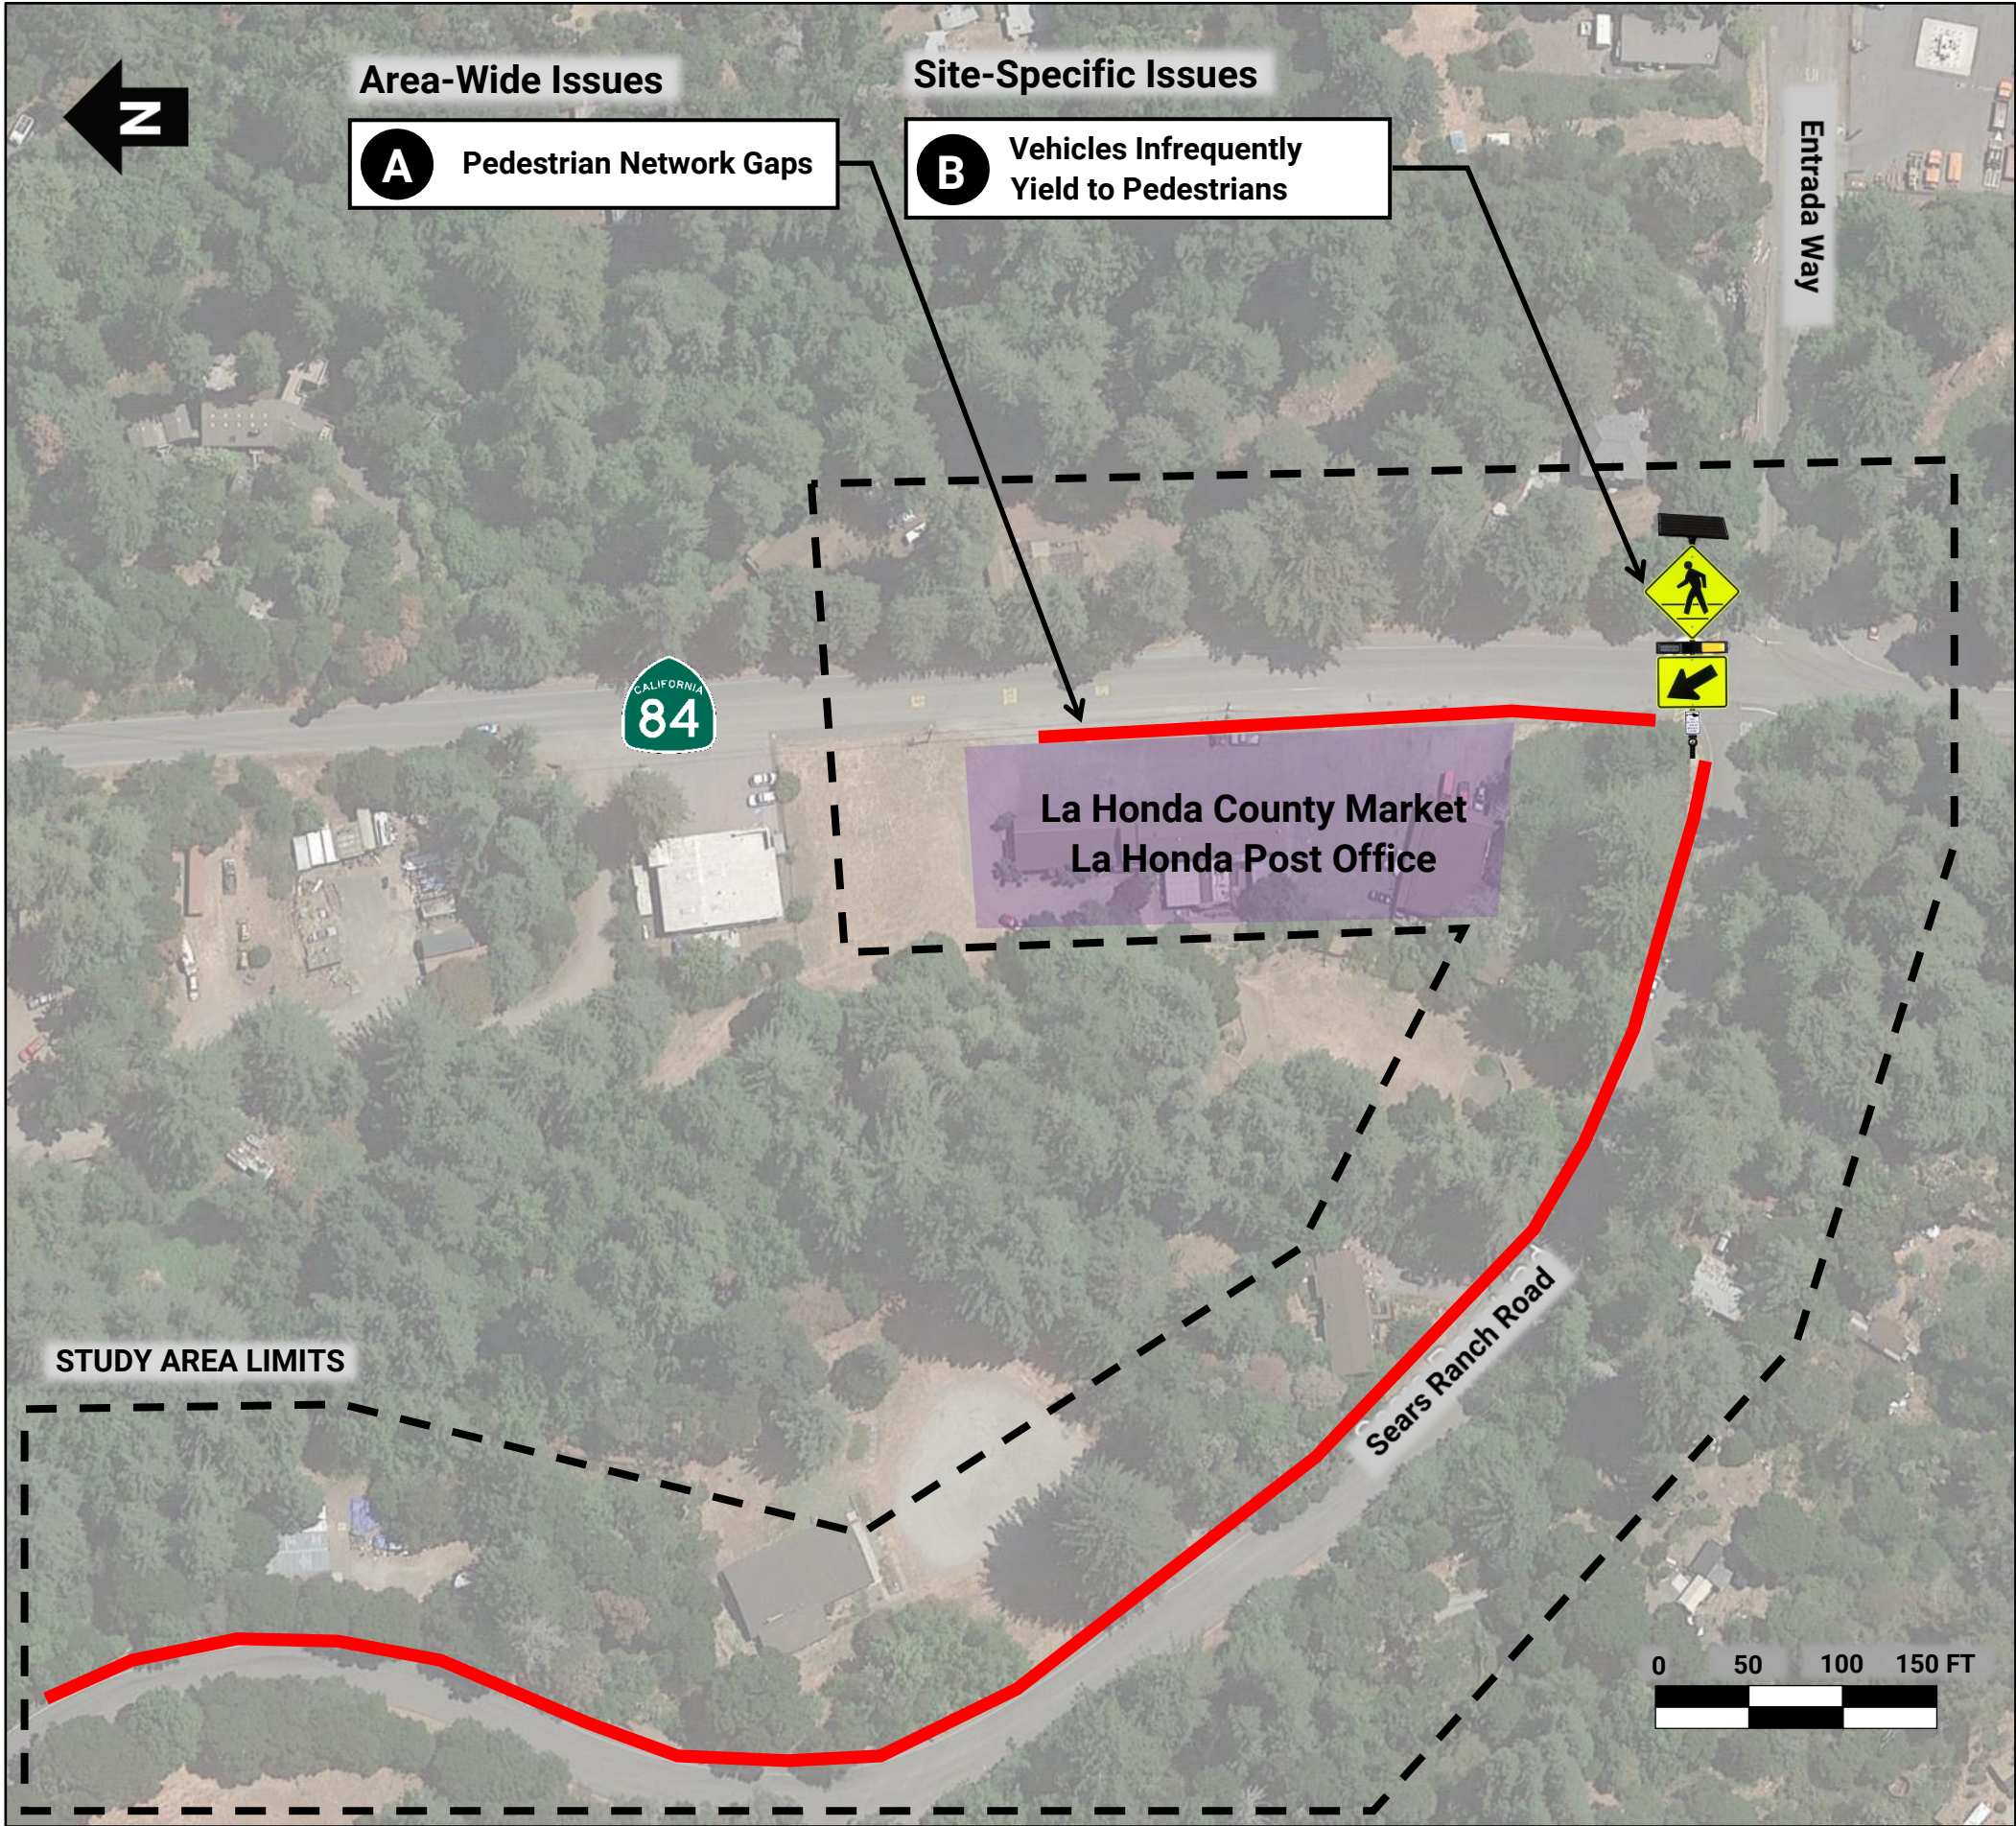
Study Area 6: Downtown La Honda
La Honda, CA

Issue	Recommendation
A	Pedestrian network gaps from the La Honda Country Market and Post Office to Sears Ranch Road and from La Honda Elementary School to SR-84 result in a disconnected and inaccessible walking network.	Short-Term <ul style="list-style-type: none">Install vertical separation (e.g., wooden curb stops) on south side of SR-84 to delineate travel lane from paved shoulder walkway from Country Market to Sears Ranch RoadInstall similar separation on east side of Sears Ranch Road from school to SR-84 to delineate travel lane from paved shoulder walkway. (This is also a recommendation from a San Mateo County Safe Routes to School walking audit conducted at La Honda Elementary School.)
B	Vehicles infrequently yield to pedestrians crossing SR-84 at Sears Ranch Road.	Short-Term <ul style="list-style-type: none">Install pedestrian-activated rectangular rapid flashing beacons (RRFBs) at existing marked crossing to increase pedestrian conspicuity and priority. (This is also a recommendation from a San Mateo County Safe Routes to School walking audit conducted at La Honda Elementary School.)

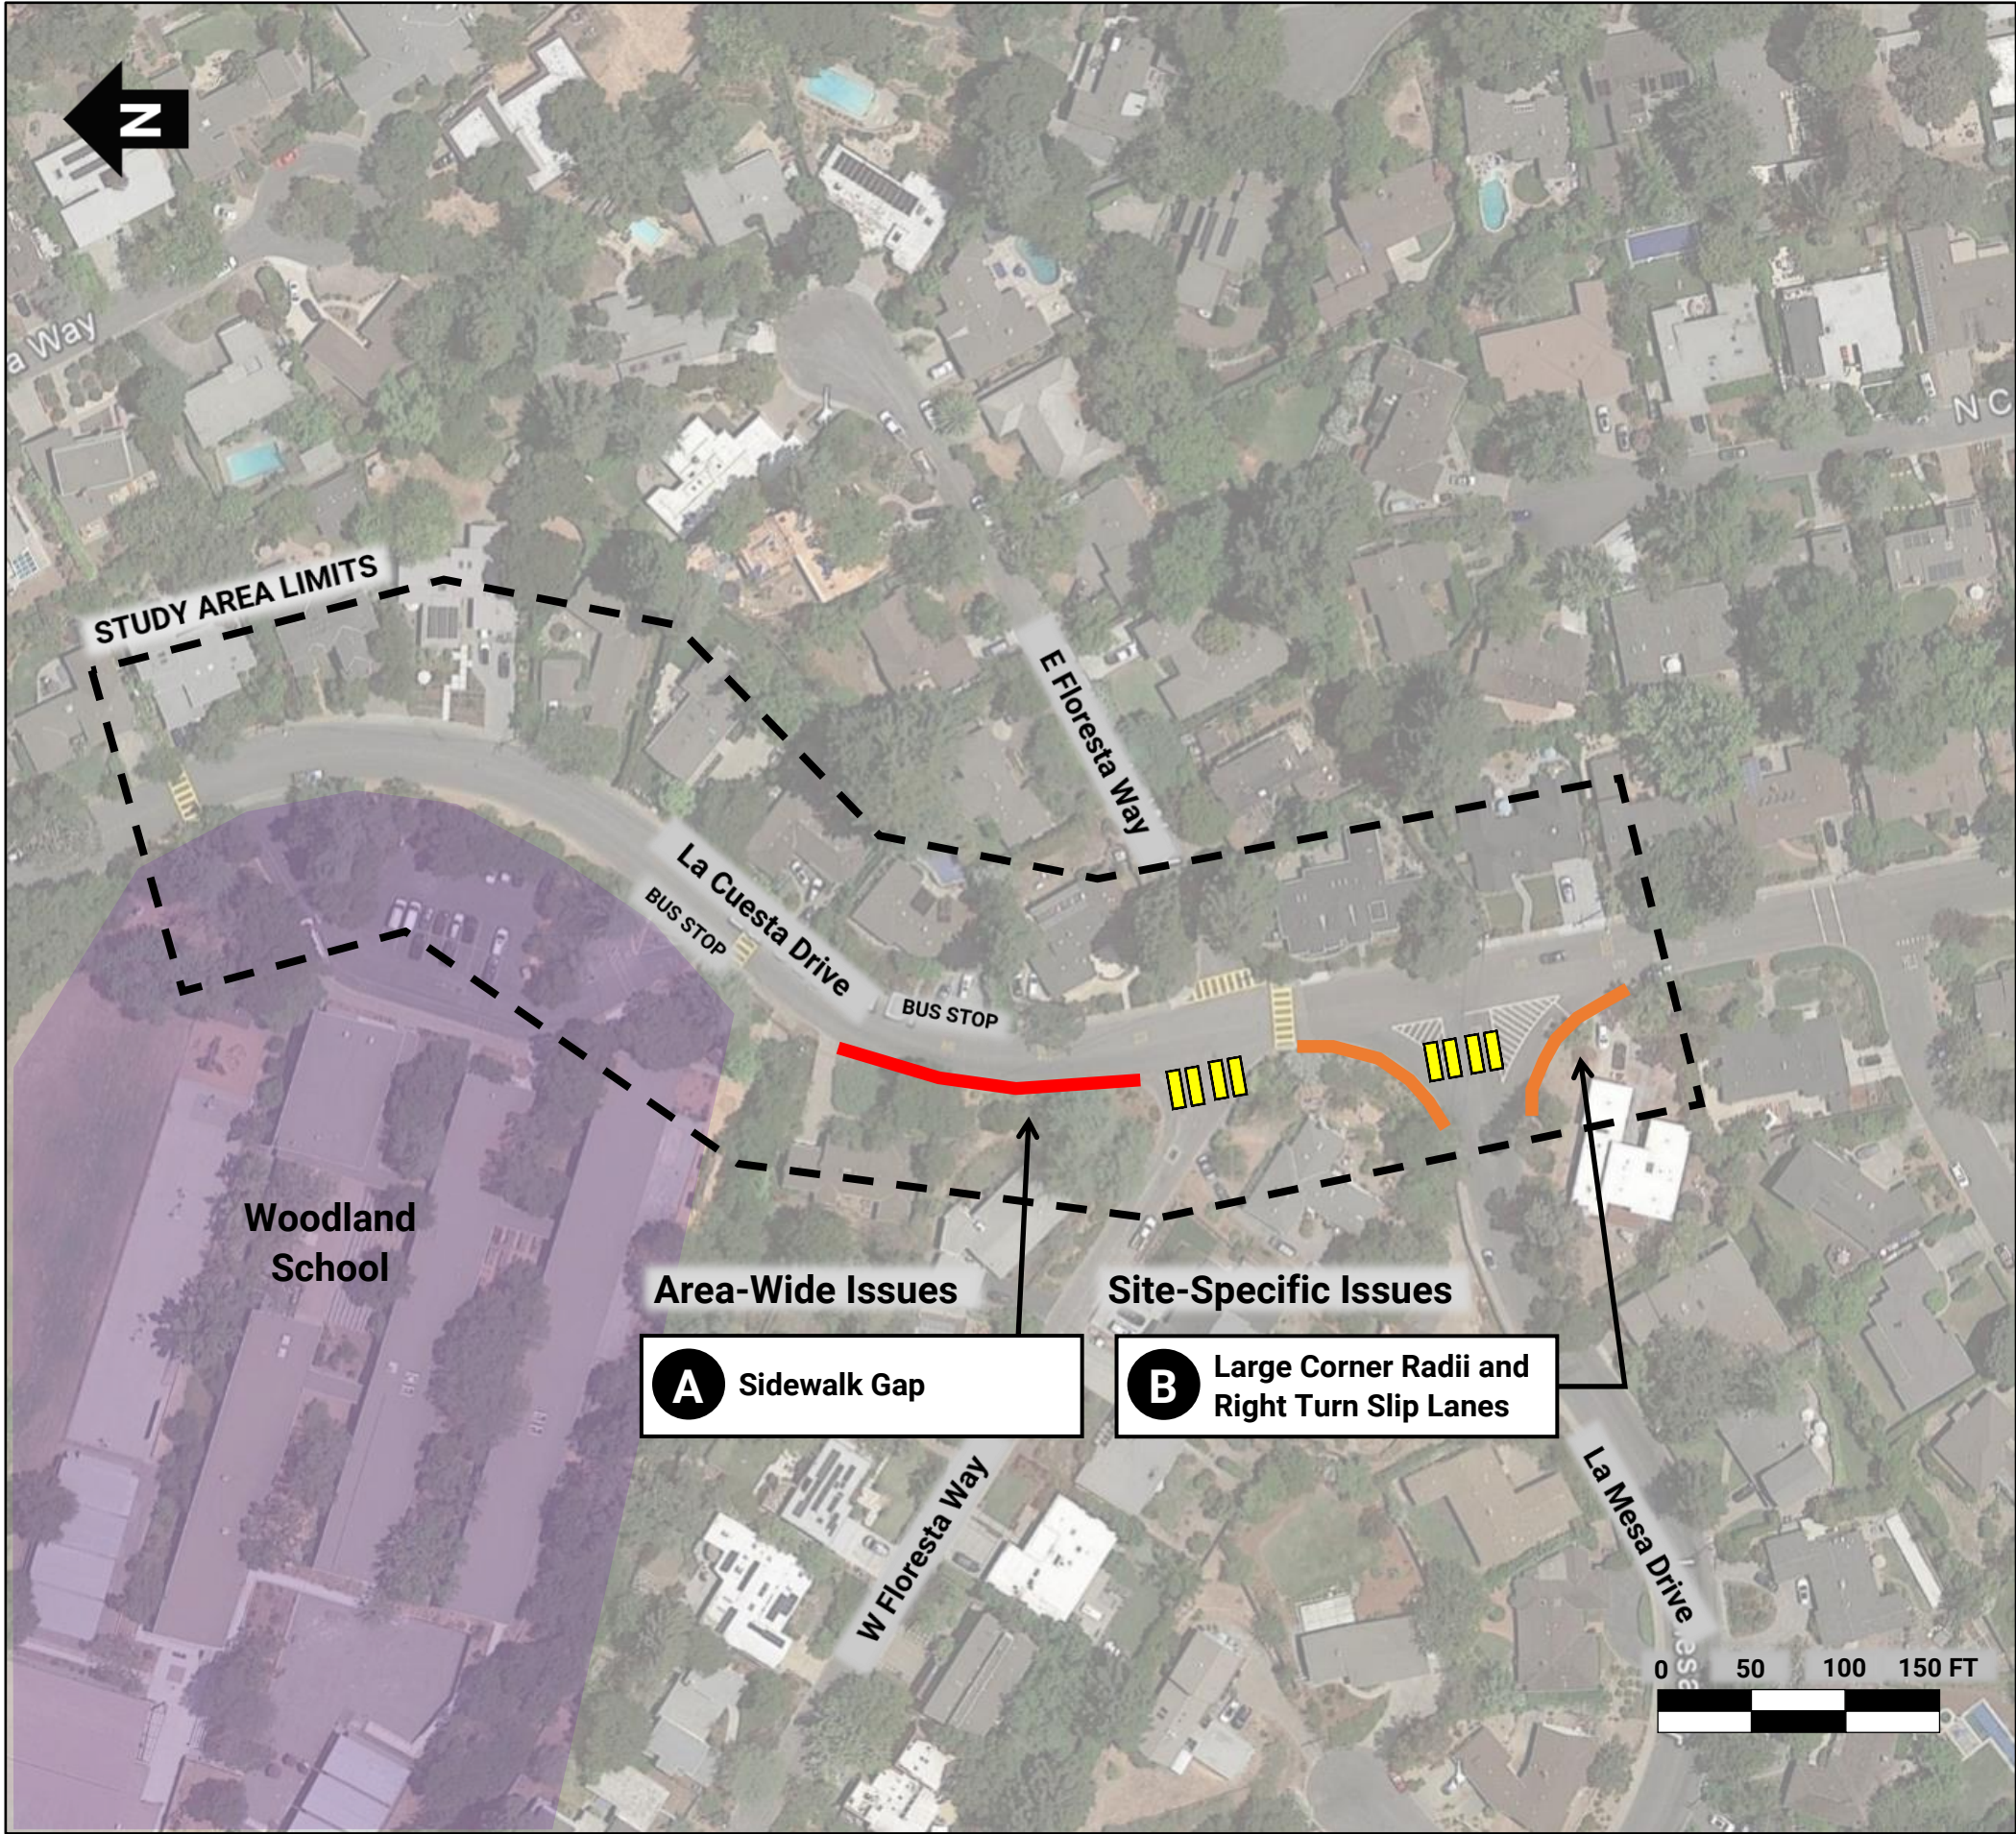
Figure 8
Study Area 7: Woodland School
Ladera, CA

Issue	Recommendation
A	Sidewalk gap results in disconnected walking network to access Woodland School from the south.	Long-Term <ul style="list-style-type: none">• Install sidewalk on west side of La Cuesta Drive from West Floresta Way to existing sidewalk south of school entrance• Install curb ramps and high-visibility school crosswalk across West Floresta Way
B	Large corner radii and right turn slip lanes result in high vehicle turning speeds and unsafe pedestrian crossing conditions at the intersection of La Cuesta Drive and La Mesa Drive.	Short-Term <ul style="list-style-type: none">• Reduce intersection footprint by closing slip lanes and reducing corner radii, using quick-build temporary materials like paint and flexible delineators Long-Term <ul style="list-style-type: none">• Reduce intersection footprint, close slip lanes, and reduce corner radii by reconstructing curblines.• When reconstructing curblines, construct curb ramps and install marked crossing at intersection

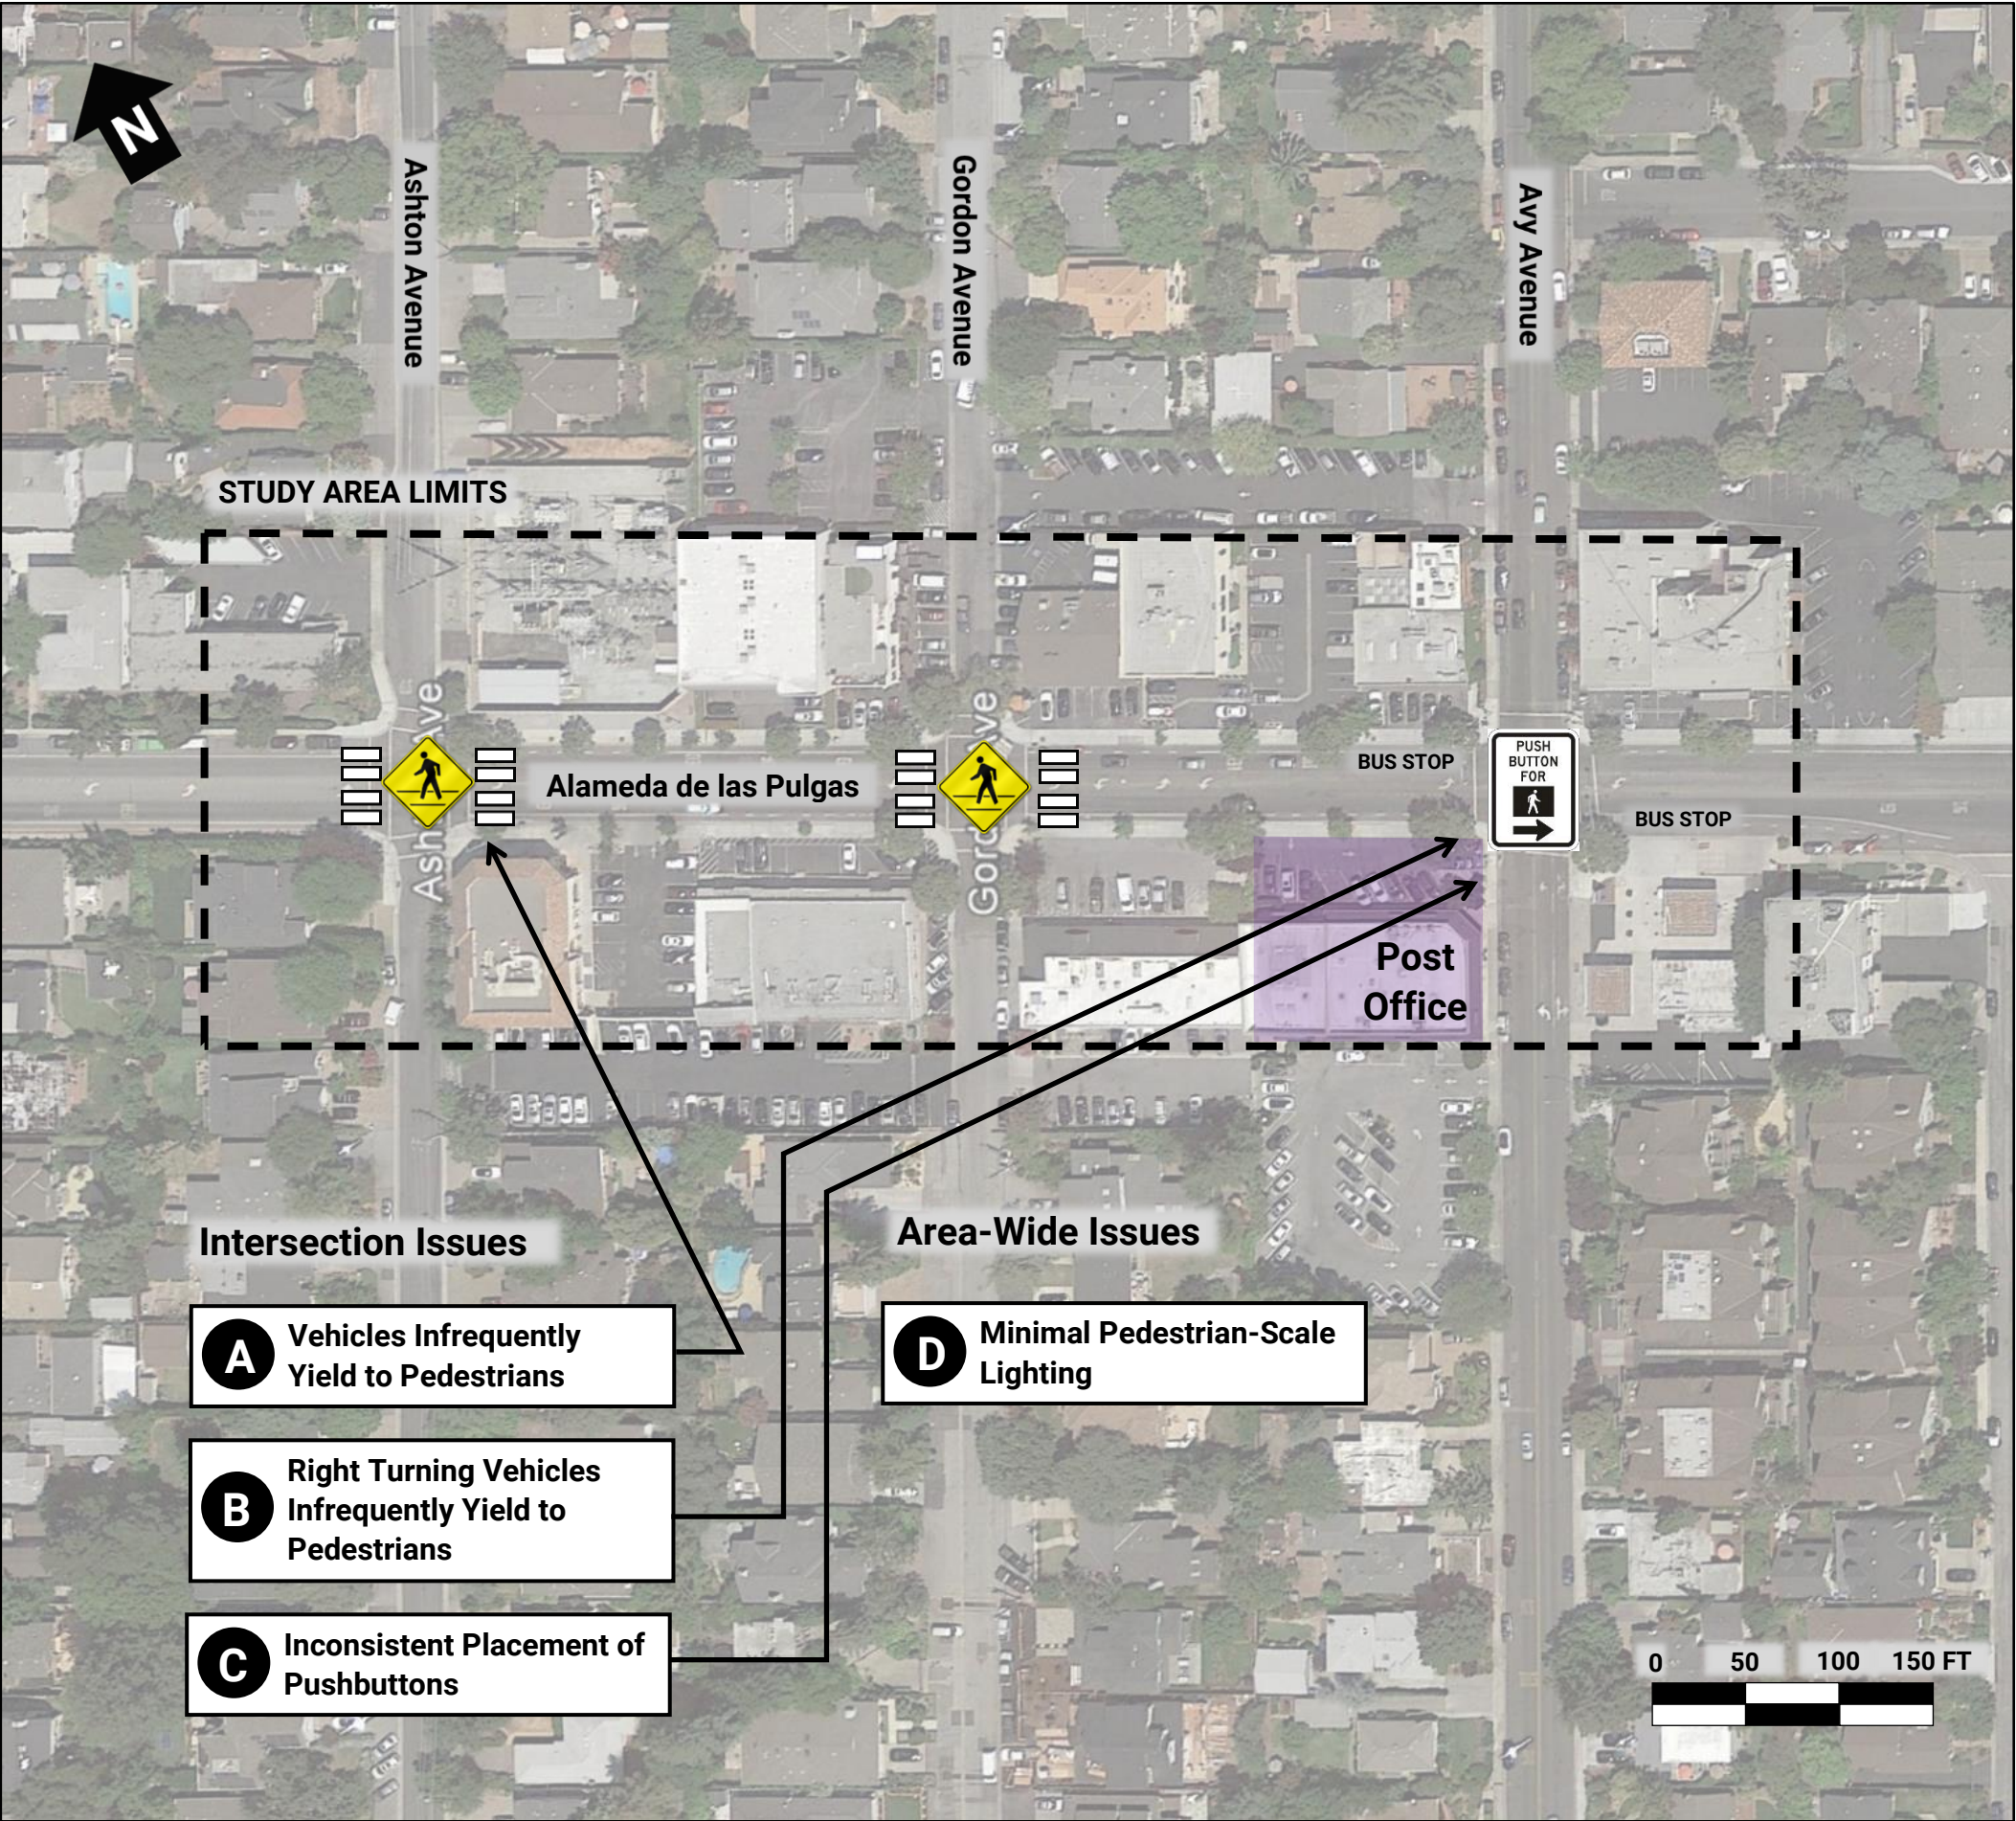
Study Area 8: Downtown West Menlo Park
West Menlo Park, CA

Issue	Recommendation
A	Vehicles infrequently yield to pedestrians crossing Alameda de las Pulgas at Ashton Avenue and Gordon Avenue.	Short-Term <ul style="list-style-type: none">Upgrade existing marked crossings to high-visibility markings to increase pedestrian conspicuity and priorityInstall pedestrian warning signage at crossings
B	Right turning vehicles infrequently yield to pedestrians , which results in an unattractive pedestrian environment.	Short-Term <ul style="list-style-type: none">Install Leading Pedestrian Intervals (LPIs), which provide pedestrians with a walk indication 3 to 7 seconds before right turning vehicles traveling in the same direction receive a green indication, so pedestrians establish the right-of-way in the crosswalk
C	Inconsistent placement of pushbuttons results in non ADA-compliant crossings at the intersection of Alameda de las Pulgas and Avy Avenue.	Long-Term <ul style="list-style-type: none">Relocate all pushbuttons (may require construction of new poles on which to place pushbuttons)

D	Minimal pedestrian-scale lighting along Alameda de las Pulgas results in an unattractive nighttime walking environment.	Long-Term <ul style="list-style-type: none">Install pedestrian-scale lighting along Alameda de las Pulgas

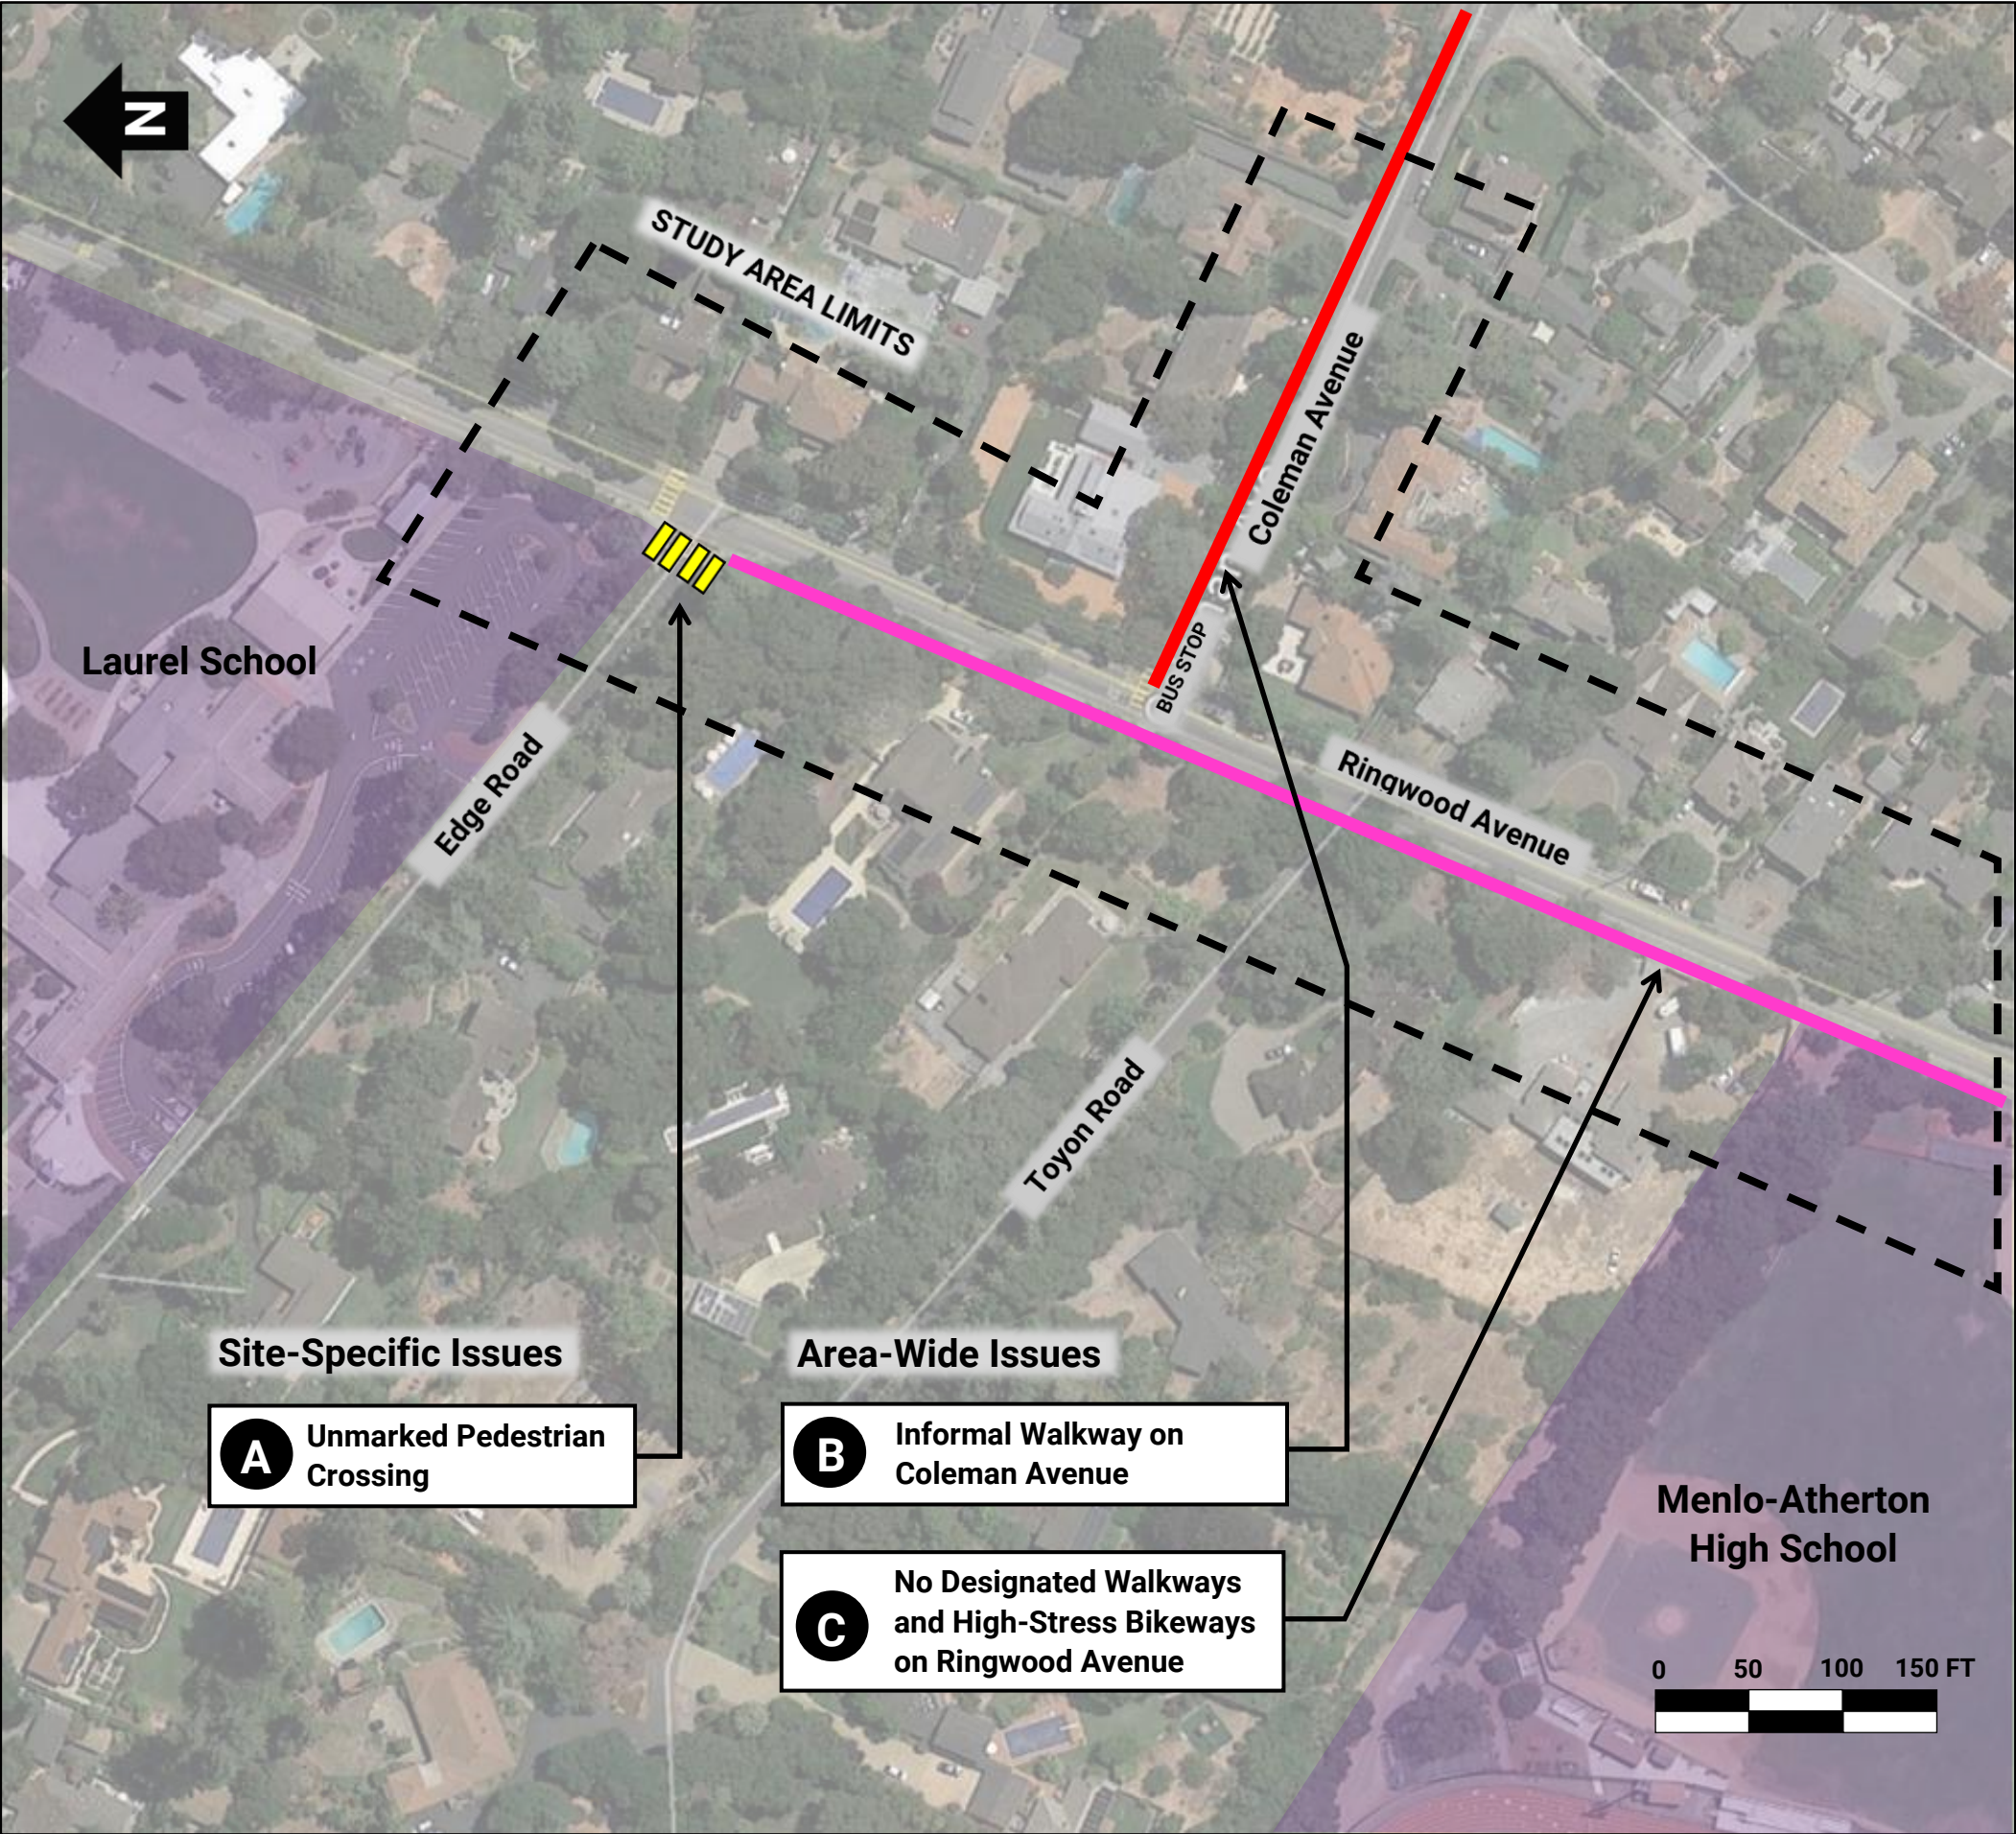
Study Area 9: Laurel School & Menlo-Atherton High
Menlo Oaks, CA

Issue	Recommendation
A	Unmarked pedestrian crossing at Edge Road, reducing pedestrian conspicuity for drivers.	Short-Term <ul style="list-style-type: none">Restripe crosswalk over Edge Road
B	Informal walkway on Coleman Avenue , resulting in pedestrian safety and access issues.	Short-Term <ul style="list-style-type: none">Formalize walkway on north side of Coleman Avenue by painting shoulder and/or installing vertical separation (e.g., wooden curb stops) to delineate shoulder walkway from travel lane
C	No designated walkways and high-stress bikeways along Ringwood Avenue , creating an unsafe walking and bicycling environment for students.	Short-Term <ul style="list-style-type: none">Install shared-use path on west side of Ringwood Avenue using low cost materials like thermoplastic striping and curb stops to delineate it from the roadway (requires further study to determine impacts to existing infrastructure)

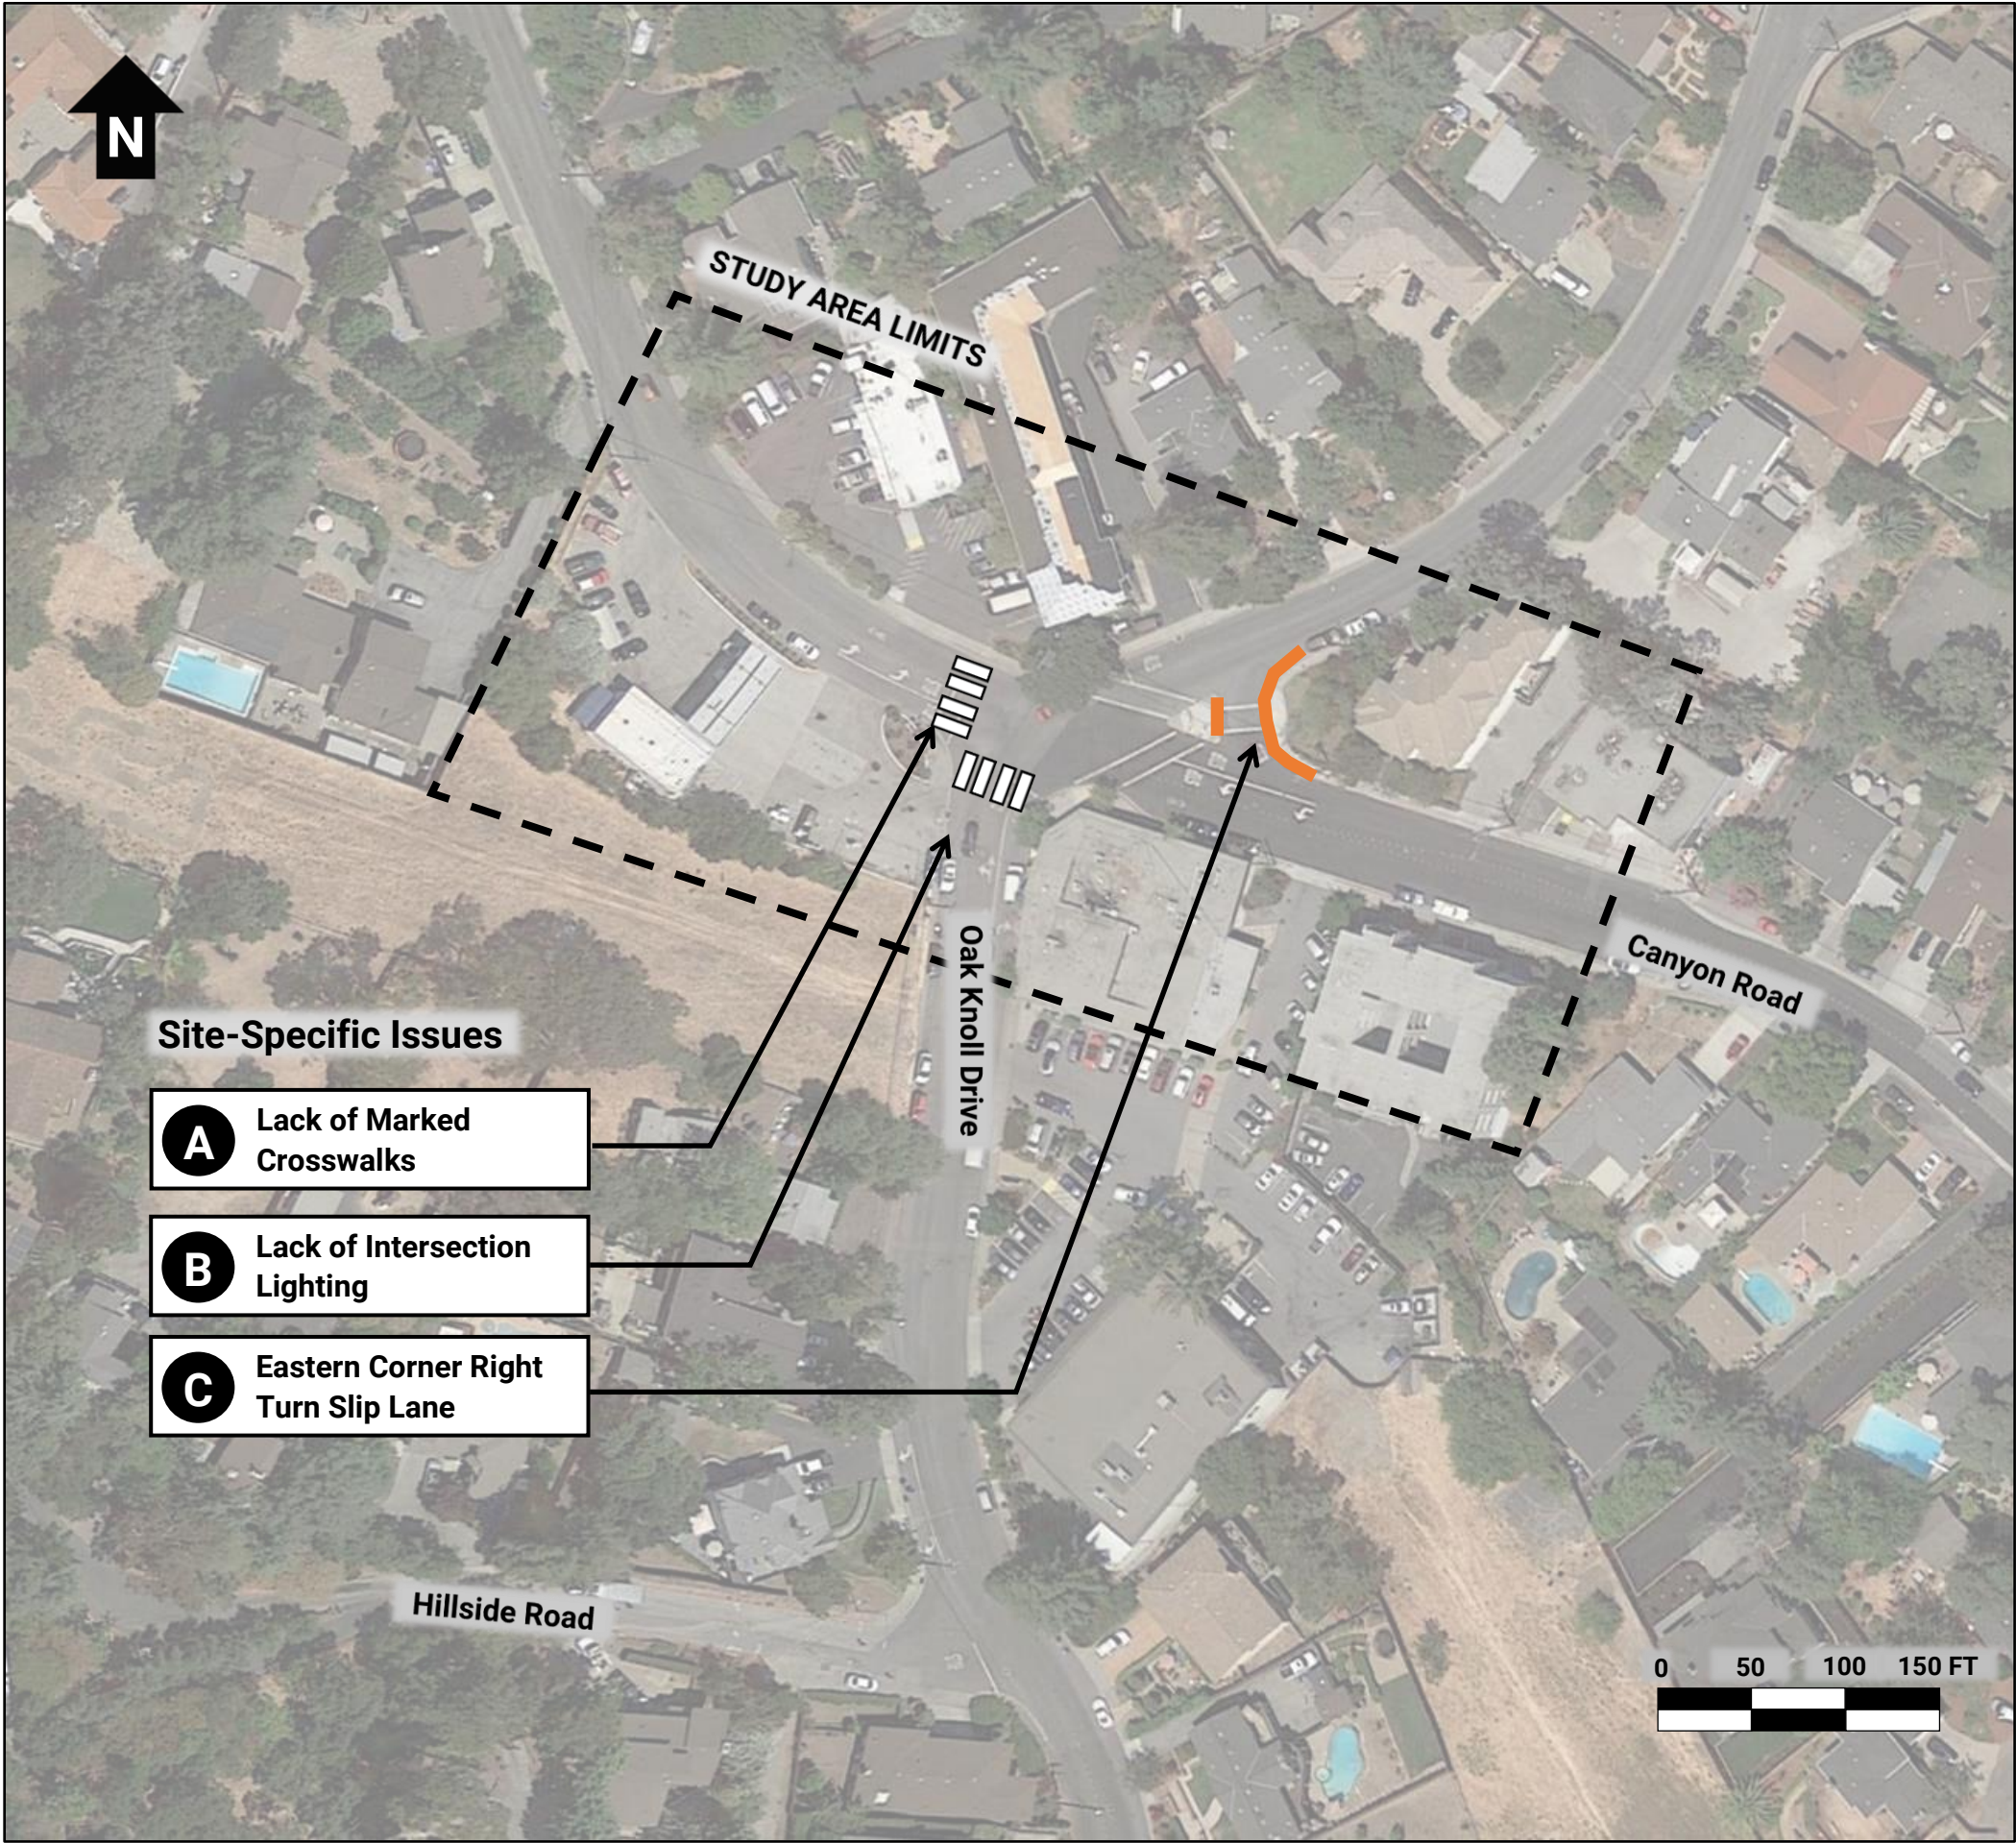
Study Area 10: Oak Knoll Drive/Canyon Road Intersection
Emerald Hills, CA

Issue	Recommendation
A	Lack of marked crosswalks at intersection, resulting in reduced pedestrian conspicuity and safety.	Long-Term <ul style="list-style-type: none">Stripe high-visibility crosswalks along western and southern legs of intersection and upgrade existing crosswalks on eastern and northern legs to high-visibility crosswalksWhen striping crosswalks, construct accessible landings
B	Lack of lighting at intersection, resulting in reduced pedestrian conspicuity and safety.	Long-Term <ul style="list-style-type: none">Install intersection lighting to illuminate crosswalks
C	Eastern corner right turn slip lane with large radius results in high vehicle turning speeds and unsafe pedestrian crossing conditions.	Short-Term <ul style="list-style-type: none">Narrow slip lane to reduce turning traffic speeds by using quick-build temporary materials like paint and flexible delineators Long-Term <ul style="list-style-type: none">Eliminate slip lane and reconstruct curbline of eastern corner with truck apron to accommodate heavy vehicles making right turn
