**Site-Specific Issues**

**Study Area 10: Oak Knoll Drive/Canyon Road Intersection**  
Emerald Hills, CA

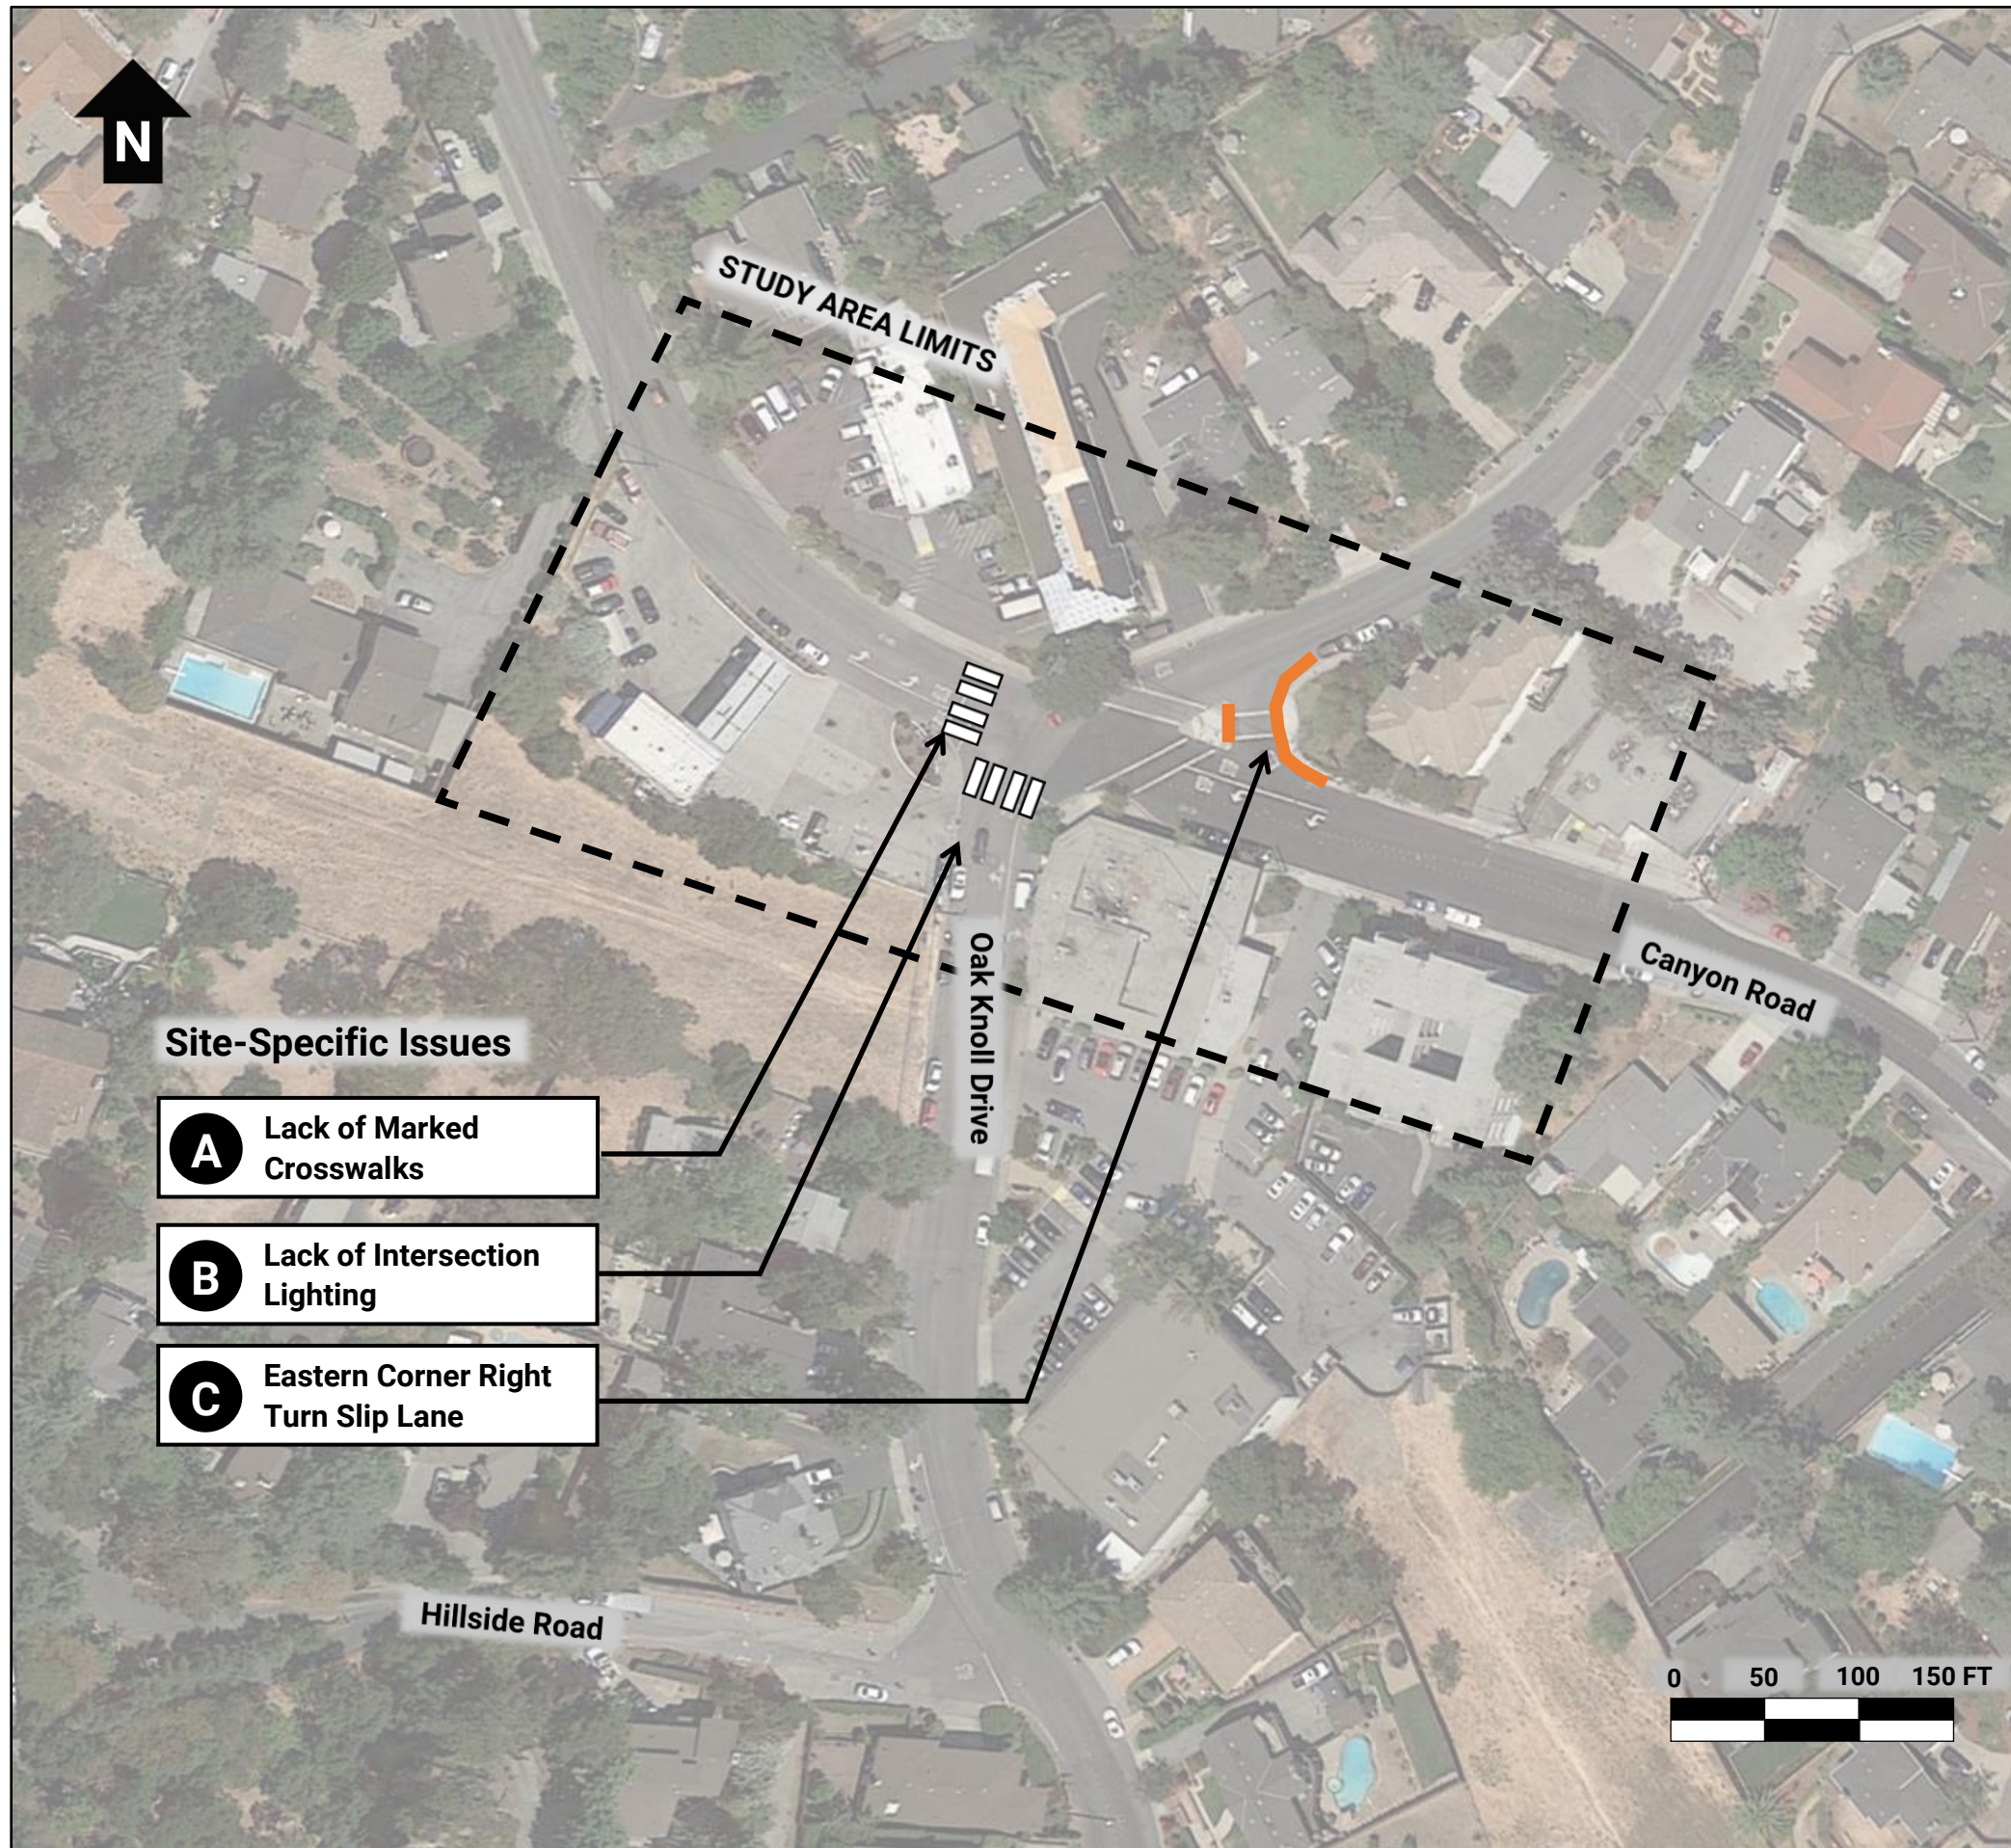
- A** Lack of Marked Crosswalks
- B** Lack of Intersection Lighting
- C** Eastern Corner Right Turn Slip Lane

<b>Issue</b>	<b>Recommendation</b>
<b>A</b>	<b>Lack of marked crosswalks</b> at intersection, resulting in reduced pedestrian conspicuity and safety.	<p><b>Long-Term</b></p> <ul style="list-style-type: none"> <li>Stripe high-visibility crosswalks along western and southern legs of intersection and upgrade existing crosswalks on eastern and northern legs to high-visibility crosswalks</li> <li>When striping crosswalks, construct accessible landings</li> </ul>
<b>B</b>	<b>Lack of lighting</b> at intersection, resulting in reduced pedestrian conspicuity and safety.	<p><b>Long-Term</b></p> <ul style="list-style-type: none"> <li>Install intersection lighting to illuminate crosswalks</li> </ul>
<b>C</b>	<b>Eastern corner right turn slip lane</b> with large radius results in high vehicle turning speeds and unsafe pedestrian crossing conditions.	<p><b>Short-Term</b></p> <ul style="list-style-type: none"> <li>Narrow slip lane to reduce turning traffic speeds by using quick-build temporary materials like paint and flexible delineators</li> </ul> <p><b>Long-Term</b></p> <ul style="list-style-type: none"> <li>Eliminate slip lane and reconstruct curbline of eastern corner with truck apron to accommodate heavy vehicles making right turn</li> </ul>
