Figure 8
Study Area 7: Woodland School
 Ladera, CA

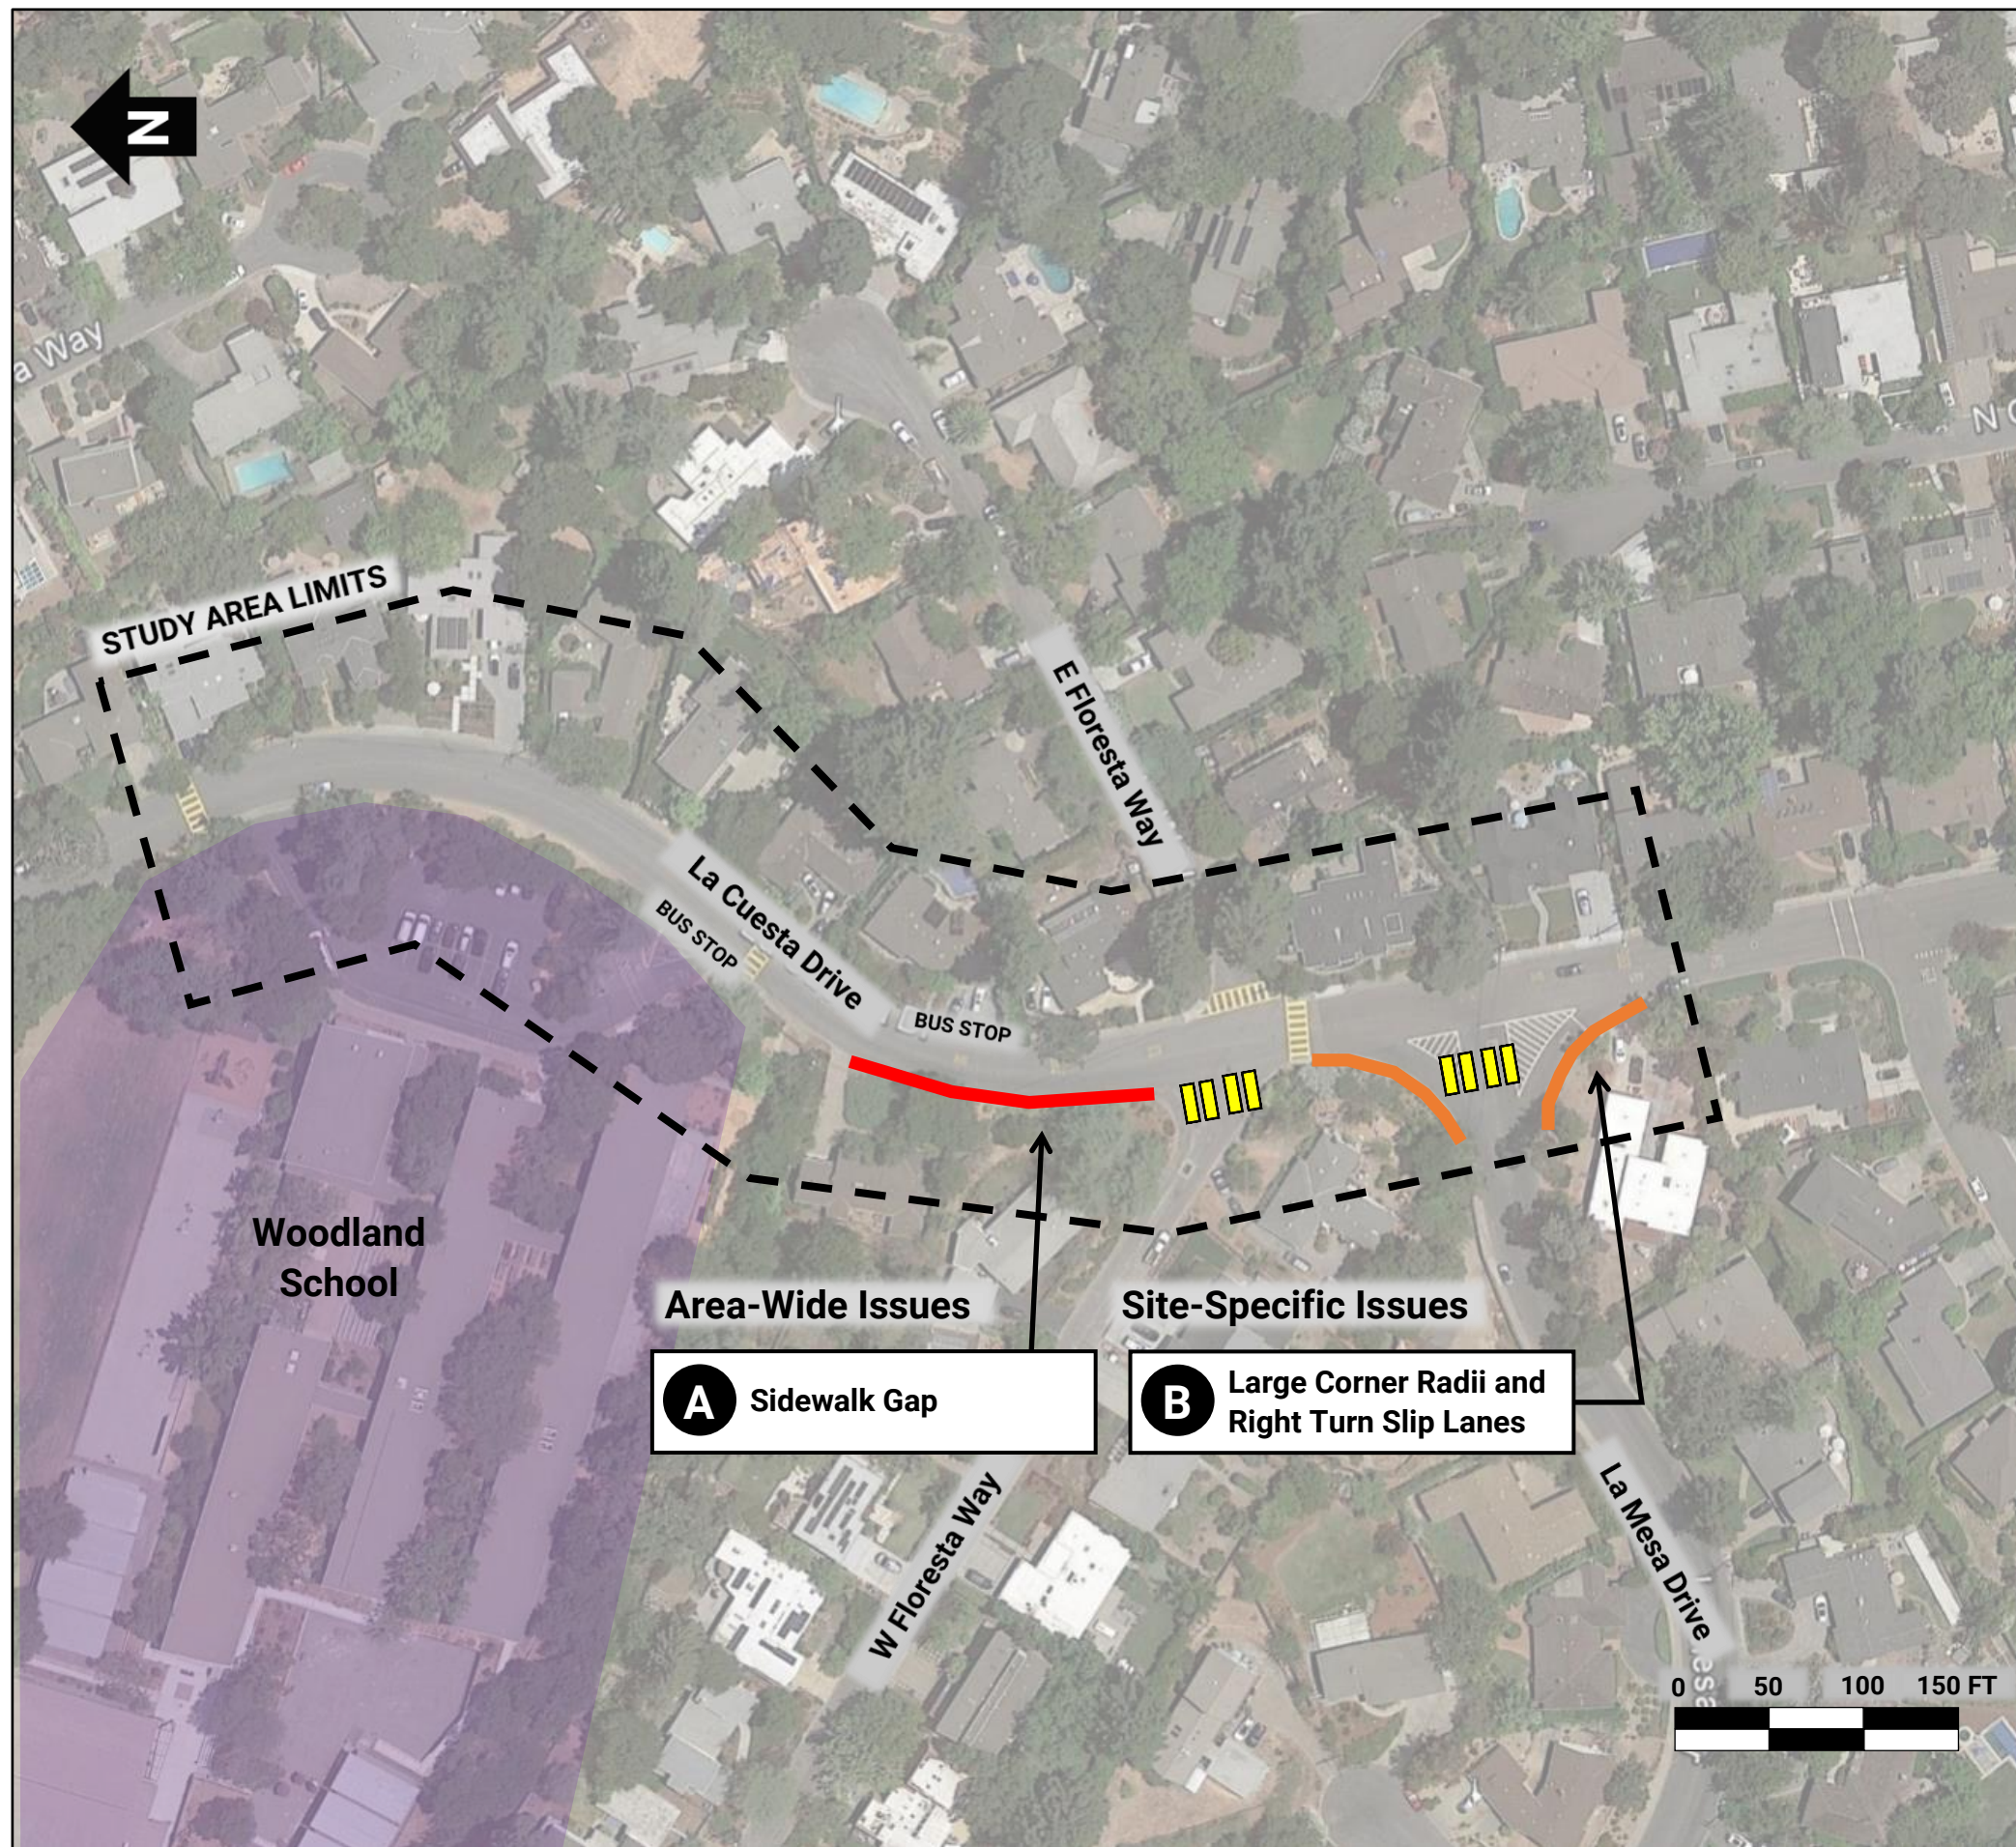
Issue	Recommendation
A	Sidewalk gap results in disconnected walking network to access Woodland School from the south.	<p>Long-Term</p> <ul style="list-style-type: none"> Install sidewalk on west side of La Cuesta Drive from West Floresta Way to existing sidewalk south of school entrance Install curb ramps and high-visibility school crosswalk across West Floresta Way
B	Large corner radii and right turn slip lanes result in high vehicle turning speeds and unsafe pedestrian crossing conditions at the intersection of La Cuesta Drive and La Mesa Drive.	<p>Short-Term</p> <ul style="list-style-type: none"> Reduce intersection footprint by closing slip lanes and reducing corner radii, using quick-build temporary materials like paint and flexible delineators <p>Long-Term</p> <ul style="list-style-type: none"> Reduce intersection footprint, close slip lanes, and reduce corner radii by reconstructing curblines. When reconstructing curblines, construct curb ramps and install marked crossing at intersection
